AIRWORTHINESS DIRECTIVE

TYPES AFFECTED: GROB G103 "TWIN 11" , SERIAL NOS. 3501 TO 3715
GROB G103A "TWIN 11 ACRO", SERIAL NOS. 3544-K-1 TO 3709-K-45

SUBJECT: Front cockpit airbrake operating lever

Technical Information
TM 315-29

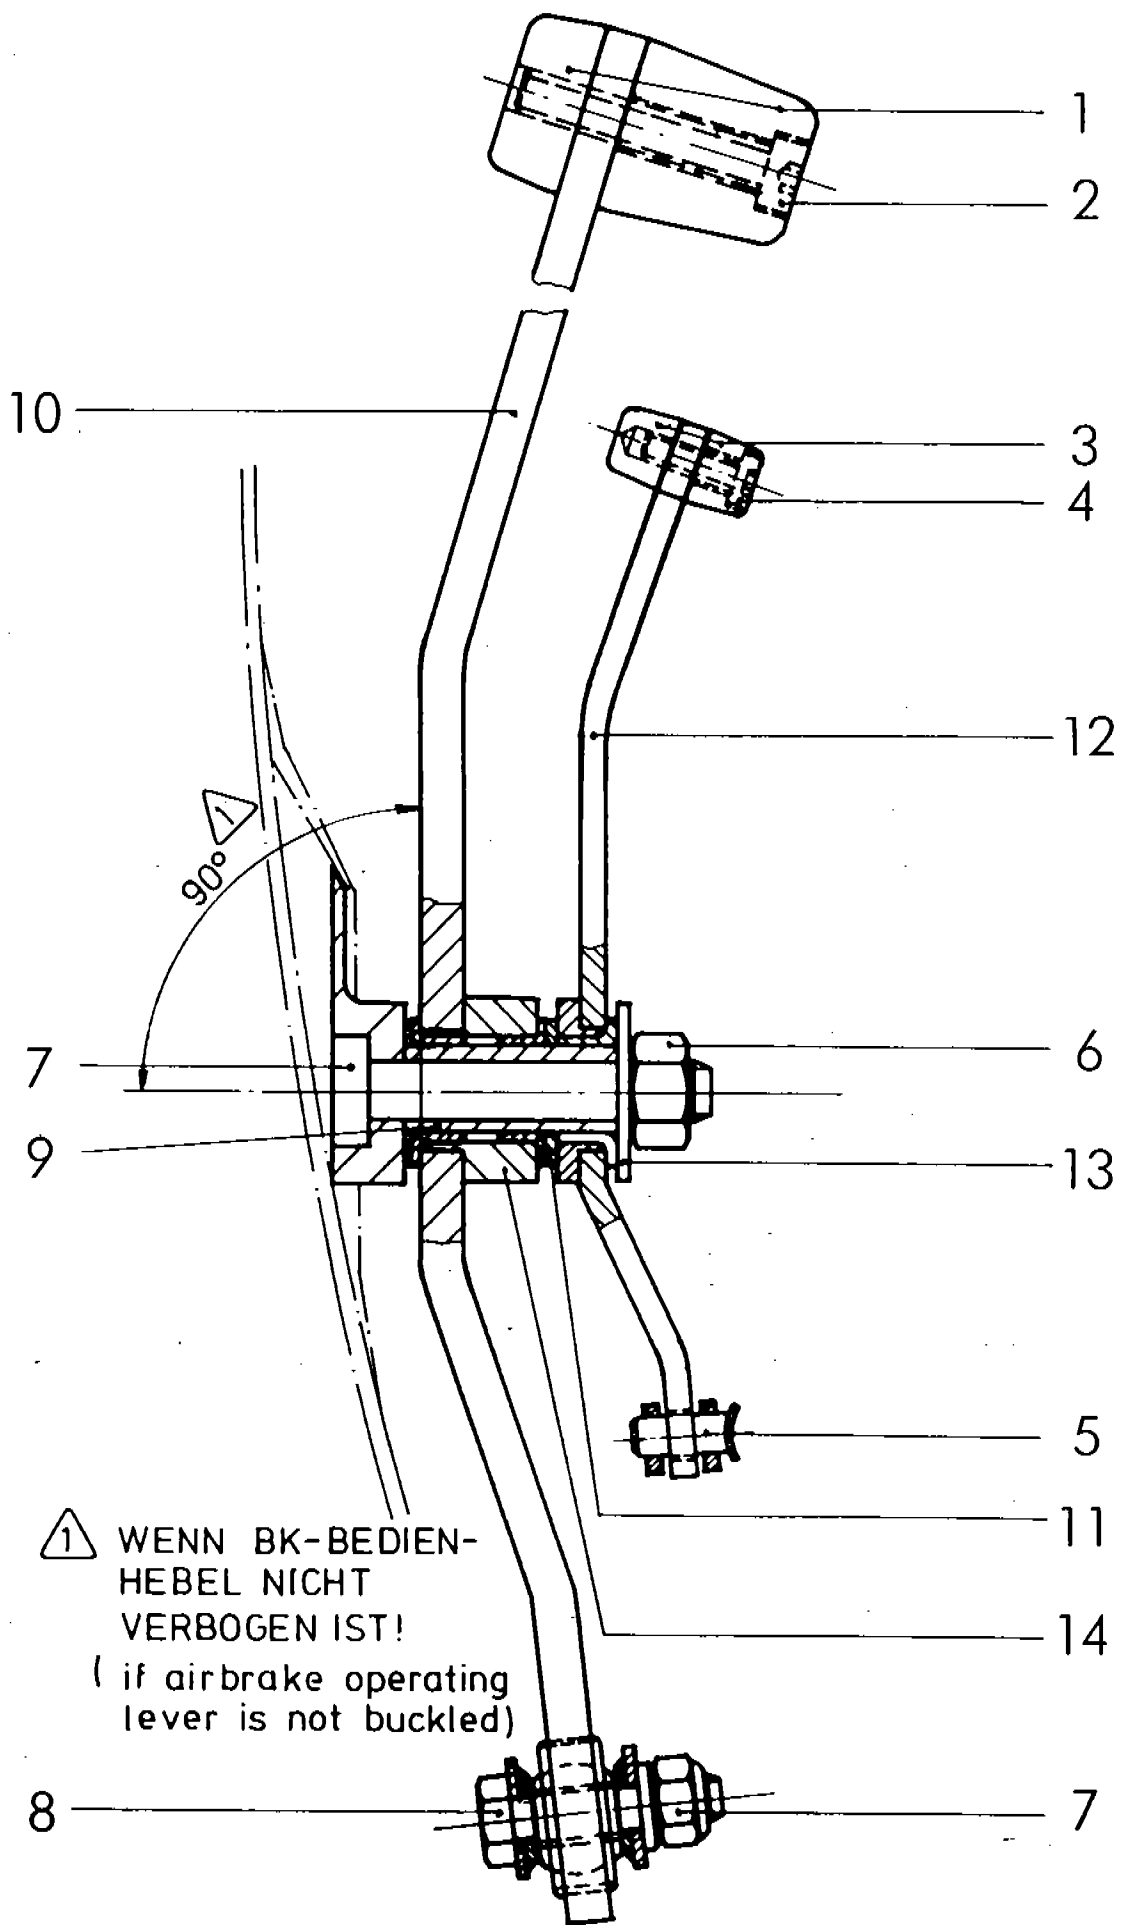
Abb.: 1
picture 1

- Instructions:**
1. Instruction: Inspection of the airbrake operating lever for cracks respectively buckling.
 - 1.1. The airbrake operating lever is to be checked for cracks respectively buckling in the region of the lever bearing (s. a. picture 1 of repair Instruction no. 315-29). For that purpose the points 1.-5. of the repair Instruction no. 315-29, which is component part of the present Technical Information, are to be carried out. For the inspection it is recommended to use a magnifying glass.

- 1.2. If cracks are found or if buckling of the operating lever is stated in the region of the lever bearing, instruction 2 is to be carried out before next flight.

- Remark:**
If the operating lever is buckled mostly the pasted in bushing (s. a. Repair Instruction No. 315-29, (14)) is broken out.
 - 1.3. If no cracks are found and if no buckling of the lever is established, it is not necessary to repeat instruction 1 till the exchange of the airbrake operating lever. Then assembly takes place in reverse sequence.

1. Put fuselage on a trestle or a trailer-dolly (only if the glider is derigged).
2. Remove front seat.
3. Remove knob at the airbrake operating lever (1) by loosening the fillister head screw M6 × 40 (2).

4. Remove knob at the trim lever (3) by loosening the fillister head screw M4 × 16 (4).
5. Unscrew and remove left side-fairing (countersunk head screws M4 × 20, red grommet M8).

6. Unhinge trim rod at the trim lever (5).
7. Dismount airbrake rod from airbrake operating lever, by loosening the screwing (hexagonal head screw M6 × 30) (8), stop-nut M6 (7).

8. Unscrew stop-nut M8 (6) from bearing screw (7) and replace old airbrake operating lever (30 mm wide) by new operating lever (40 mm wide). In doing so, pay attention to the correct assembly (sequence of stringing on the bearing screw: Tube (9)/airbrake operating lever (10)/DU-disc (11) / trim lever (12) / disc (13) / stop-nut (6)).

9. The further assembly takes place in reverse sequence. The new delivered stop-nuts for pos. (6), (7) and for the red grommet are to be used.
10. Before screwing on the left side-fairing, a function test must be carried out in rigged condition.
