# AIRWORTHINESS DIRECTIVE

TYPE AFFECTED: ASK 21 - All serial Nos. up to 21345 (inclusive)

SUBJECT:

**ASK 21**  
**Technical Note**  
**No.20**

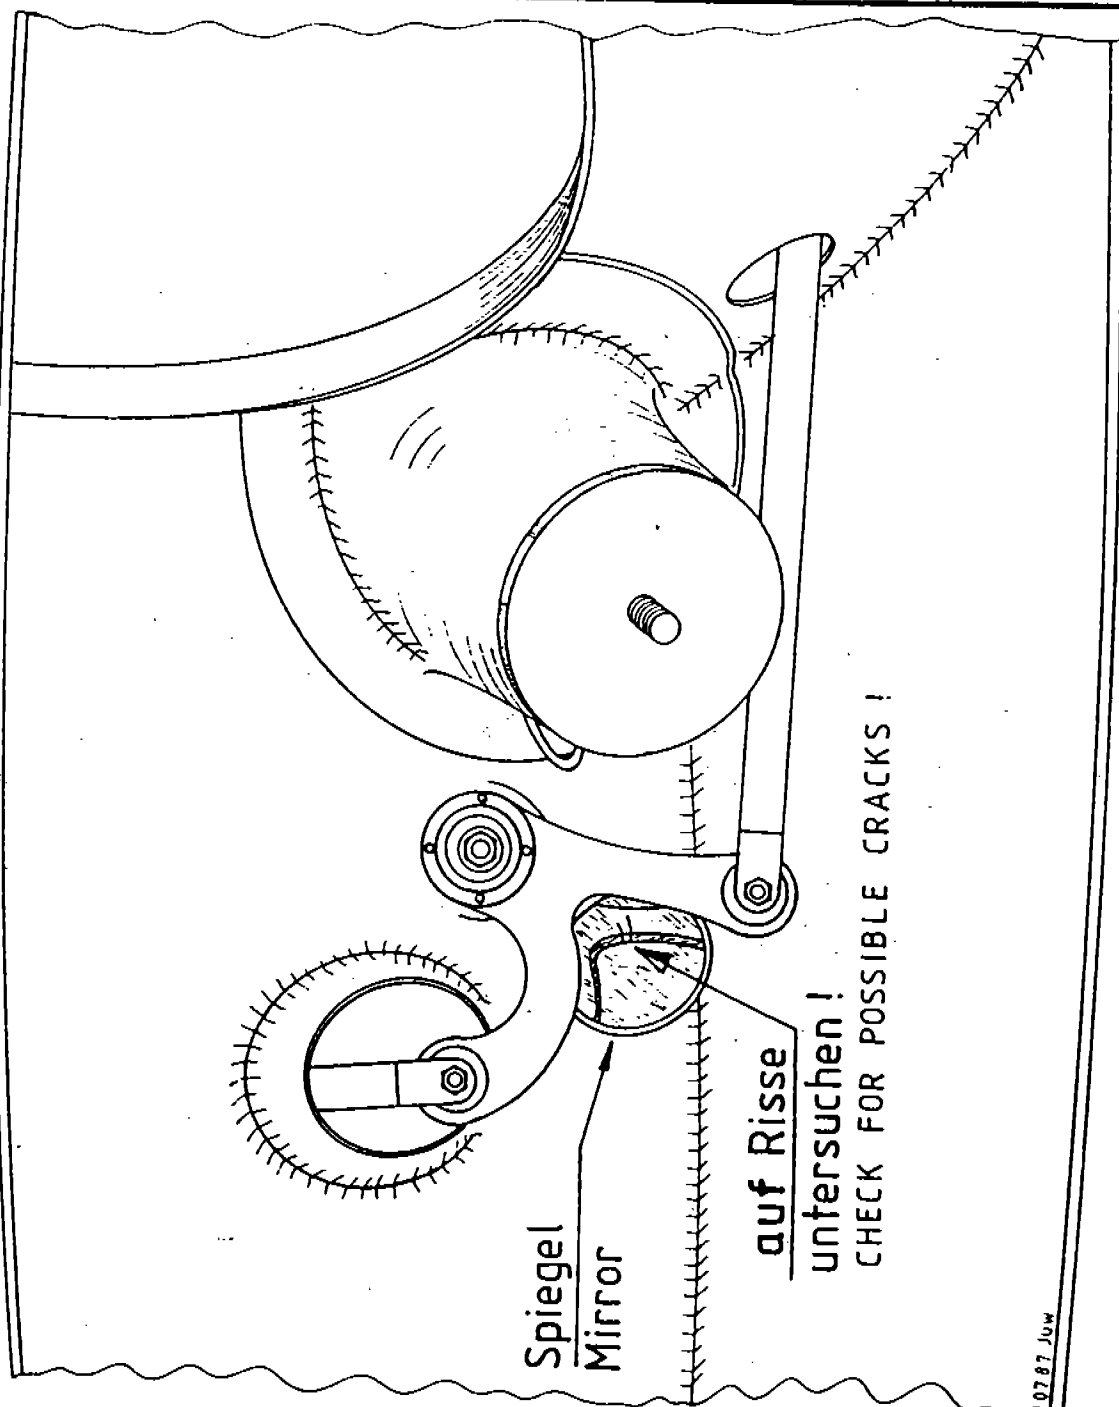
3. In two cases the pre-flight checks on the ground with the ASK 21 showed the airbrake bellcrank in the fuselage (210.43.0005) cracked --> see Maintenance Manual p.16, item 5 (for the US-edition of the manuals see the corresponding "Instructions For Continued Airworthiness" p. 19, item 5 ).

3.1 Prior to the next take-off it must be checked if the air-brake bellcrank in the fuselage shows cracks or deformations --> see Fig. 1.

3.2 If cracks or deformations are found, the airbrake bellcrank must be removed prior to the next take-off and the new bellcrank with an additional support must be fitted --> see drawing 210.43.S5.

3.3 If no damages are found, flight operation can be continued for the present. Until the next annual glider re-inspection, however, at the latest by April 30, 1988, the new bellcrank in the fuselage (210.43.0005) must be fitted.

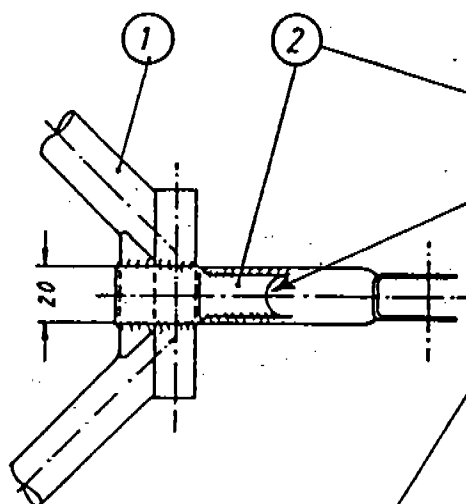
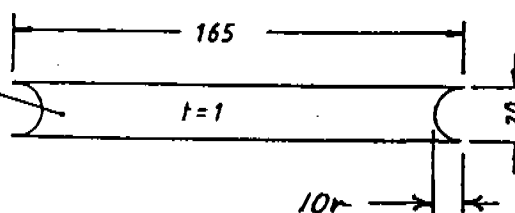
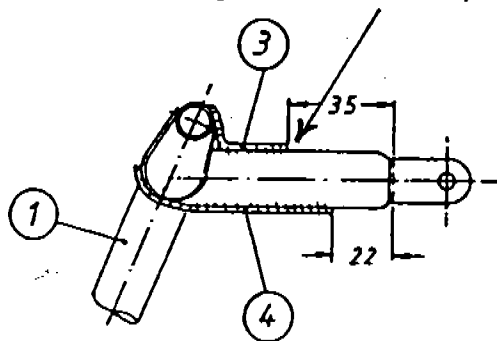
| | | A. Schleicher GmbH & Co<br>Segelmugzeugbau<br>6416 Poppenhausen | | | Zeichnungsnummer L-339<br>210.12.55 | | Blaß<br>2<br>2 Bl |

4. With a few ASK 21s the support tube for the gas spring at the rear canopy hinge was broken. These cracks result from the fact that the gliders were left outside with the canopy open for a longer period of time and by this an overload of the canopy hinge due to continuous shaking in the wind was caused. This is a gross operating error ! On the Flight Manual p. 37, V.3, it is clearly stated "When parking the sailplane the canopies have to be locked." (For the FAA-approved US-Edition of the Flight Manual this is p.43, V.3. !).

4.1 Prior to the next take-off it must be checked if the rear canopy hinge shows cracks --> see drawing 210.12.S5.

NOTE: DO NOT WELD ACROSS THE  
ENDS OF THE REINFORCING  
STRIPS.

Welding required to modify the rear canopy hinge is to be carried out by a DoTC licensed welder or a GFA authorised welder. The welder is to record the work by logbook entry.

4.2 If cracks are found, prior to the next take-off the rear canopy must be disassembled and the canopy hinge must be reinforced as shown on drawing 210.12.S5.
