## GFA AIRWORTHINESS DIRECTIVE

- TYPE AFFECTED:** SZD-38A 'Jantar 1'
- SUBJECT:** Replacement of the wing spar spigots at 1500 hours total time in service and the extension of the service life to 4500 hours total time in service.

| PDPs<br>"PZL-BIELSKO" | BULLETIN No BE-028/87 "JANTAR-1" | Page: 1<br>of: 3 |
|---|---|---|
| <p>BULLETIN No BE-028/87 "JANTAR-1"</p> <p>Ref: Life-time of SZD-38A "JANTAR-1" sailplanes</p> <p>Way of introducing: Obligatory when 1500 flying-hours have been completed.</p> <p>Elaborated in PDPs-TKS<br/>on 1987-01-20</p> <p>Director of PDPs "PZL-BIELSKO"</p> <p>Dipl. Ing. J. CIEŚLA</p> <p>This is the translation of original Polish text approved<br/>by C.A.C.A.</p> <p>Translated by:<br/>Dr Ing. W. Stafiej</p> | | |

BULLETIN No BE-036/89 "JANTAR 1"

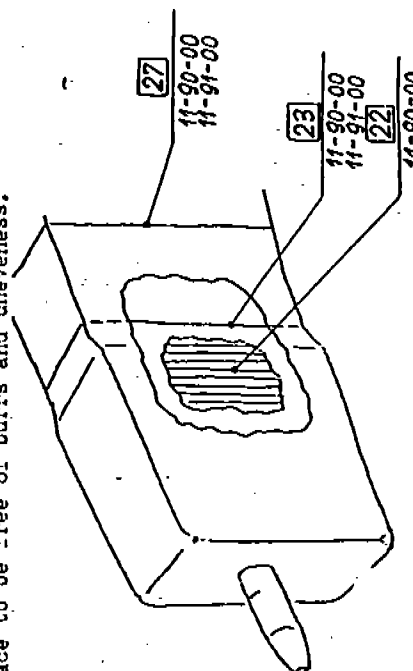
- 1.5. Remove the covering 27 and 23 as well as the roving braid 22 (Drawings 11-90-00 and 11-92-00). Clean the spar surface to be free of burrs and unevenness.

2.3. Using the face plate of the tool fit the pivot with block the cavity between the spar longerons and the wall (it should be fitted with no stressing).
