GFA AD 340

## AIRWORTHINESS DIRECTIVE

Wing tip fore/aft freeplay allowance.

B U L L E T I N No BR-032/87 "JANTAR"

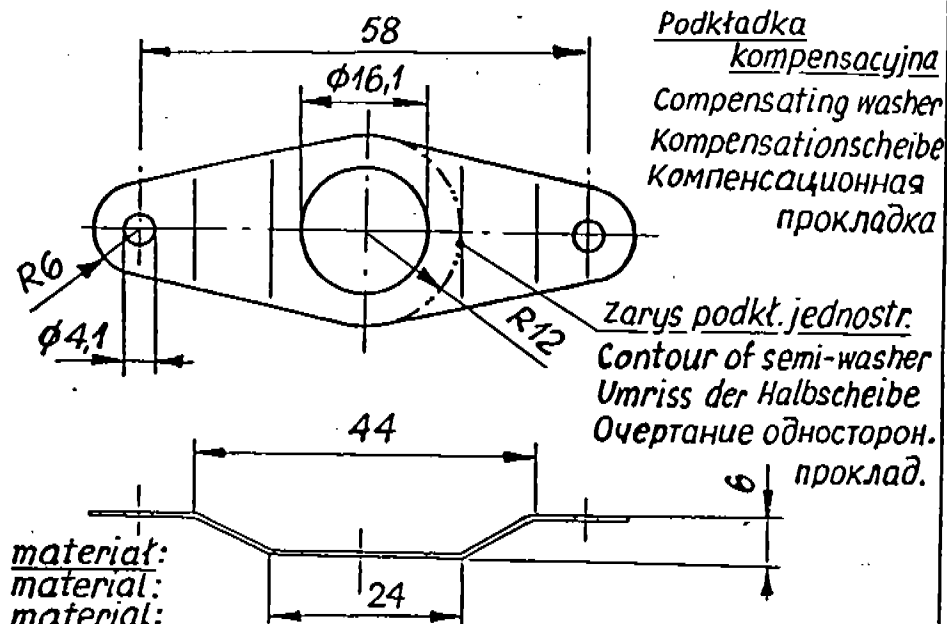
Fig.1.

blacha, metal-sheet, Blech,  
пластинка:  $\pm 0,6$  mm  
w gat., sort, Sorte, сорт (20-N)

5.3. On the places where the compensation is required /the pivots concerned/ the proper special washer /Fig.1/ should be assembled and if necessary the additional washer added /Fig.2/ so that :
