## AIRWORTHINESS DIRECTIVE

TYPES AFFECTED: Jantar SZD-48 and SZD-48-1 gliders  
Serial Nos:-  
from W-846 to W-926  
from B-985 to B-1064  
from B-1095 to B-1124  
from B-1135 to B-1274

SUBJECT: Inspection of trim spring system

BULLETIN No BR-033/88 "JANTAR St.-2"

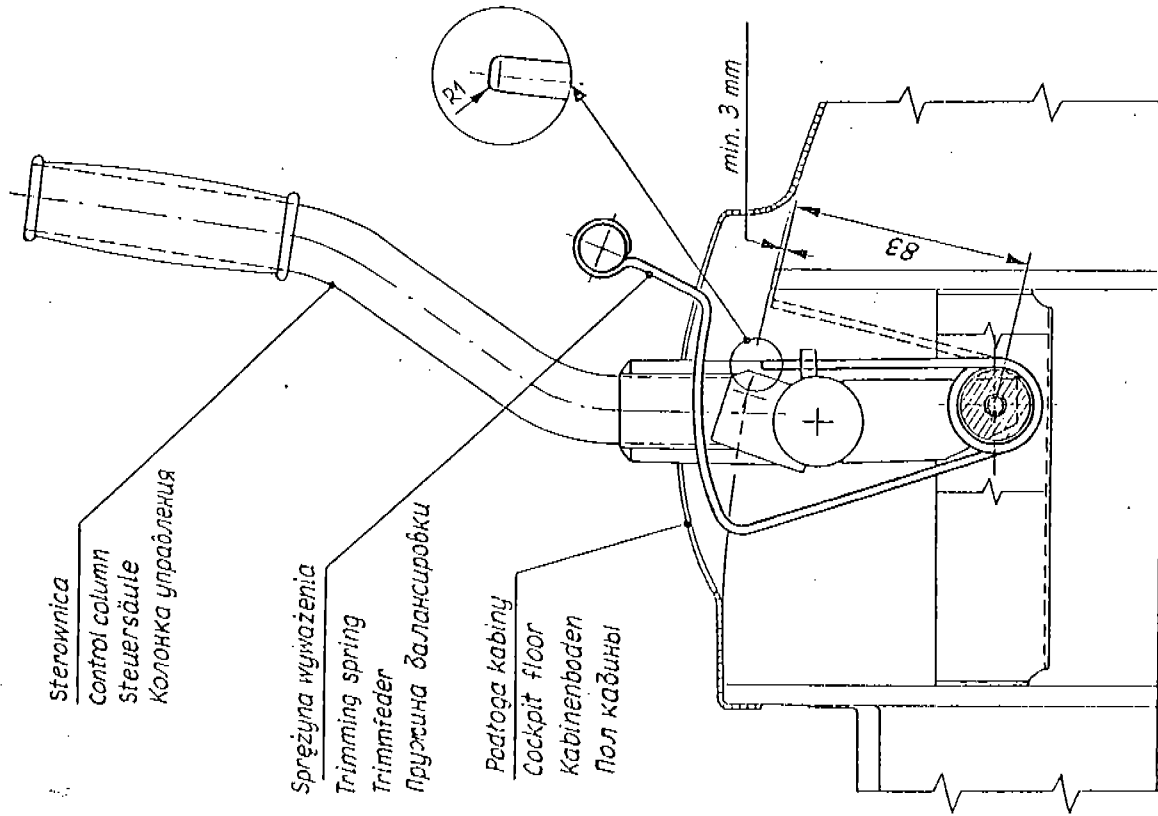
Fig. 1.

During the post-repair test flight of SZD-48 glider the following occurred : the end of trimming-spring /the arm fitted in the "eye" on control column body/ hitched the composite floor of the cockpit /"seating pan"/. In respect to the above according to directions of this Bulletin the inspection should be performed to check that the spring end to floor distance retains the minimum clearance.

4.3. Measure the disassembled spring and check the length of the arm fitted in the "eye" on the control column body /see Fig.1/. The arm length should be 83 mm. If the arm is longer it should be grinded for the correct dimension and the end rounded as shown on the sketch. If the dimension is correct the end should be rounded only.

4.4. Reassemble the total unit. Move the arm of the trimming-spring into its front limit position and pull the control stick "back" and check the distance of spring end to floor /minimum clearance should range 3 mm/ through the opening near the stick.
