AIRWORTHINESS DIRECTIVE

TYPES AFFECTED: SCHEMPP HIRTH VENTUS C , SERIAL No. 285,
288 through 290 and 292 through 382.
SCHEMPP HIRTH VENTUS cT, Serial No. 66 and 70 through 112

SUBJECT: Inspection and modification of airbrakes.

Subject : Airbrakes

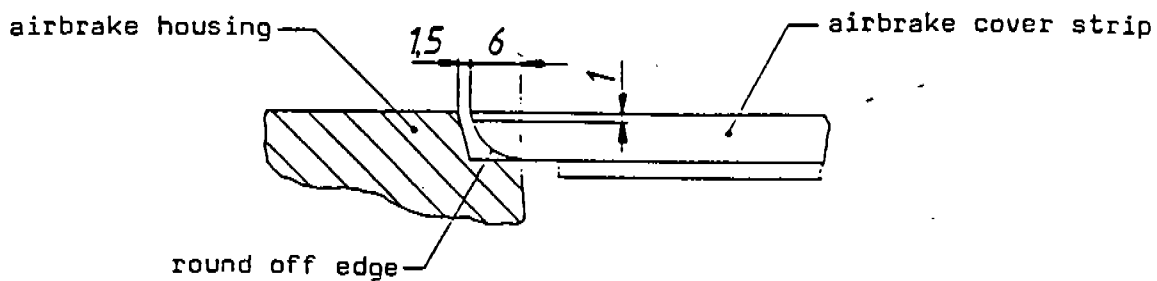
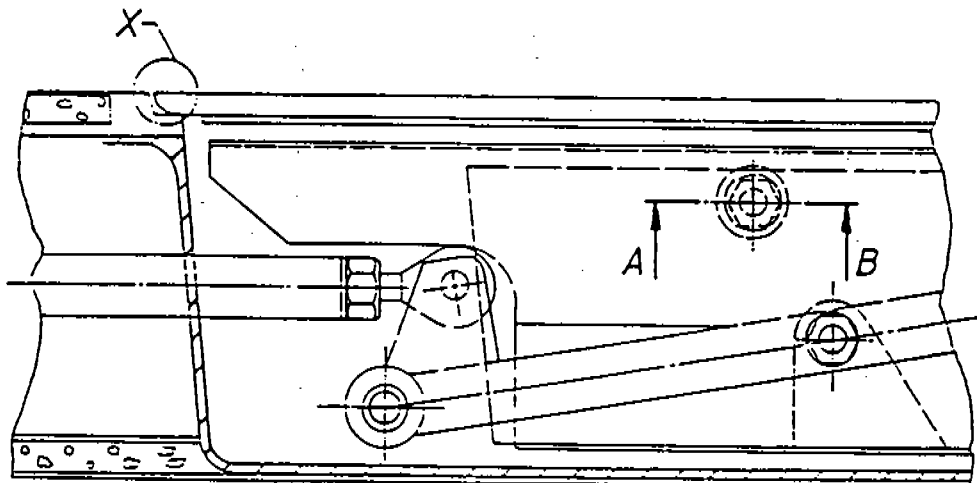
DETAIL X - SCALE 1 : 1

Should the gap on the inboard end - between the cover strip and the inboard edge of the airbrake housing - be too narrow, the cover strip gets jammed and makes the extension of the airbrakes difficult or impossible. Several such incidents have been reported.

2. Round off the lower edge of the cover strip on the inboard end as shown on page 03.

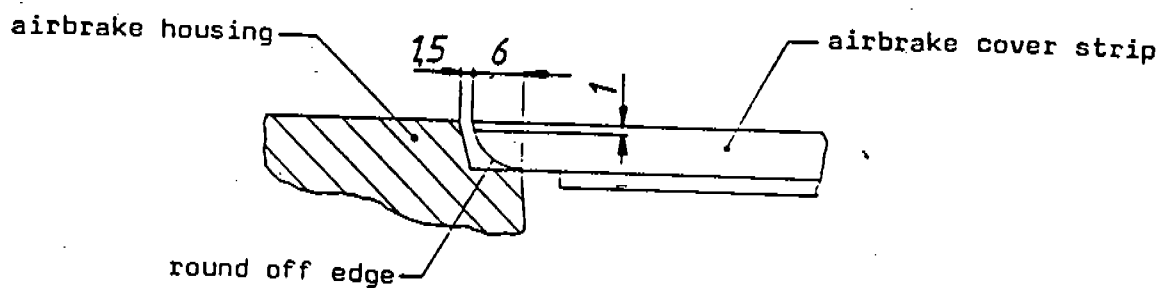
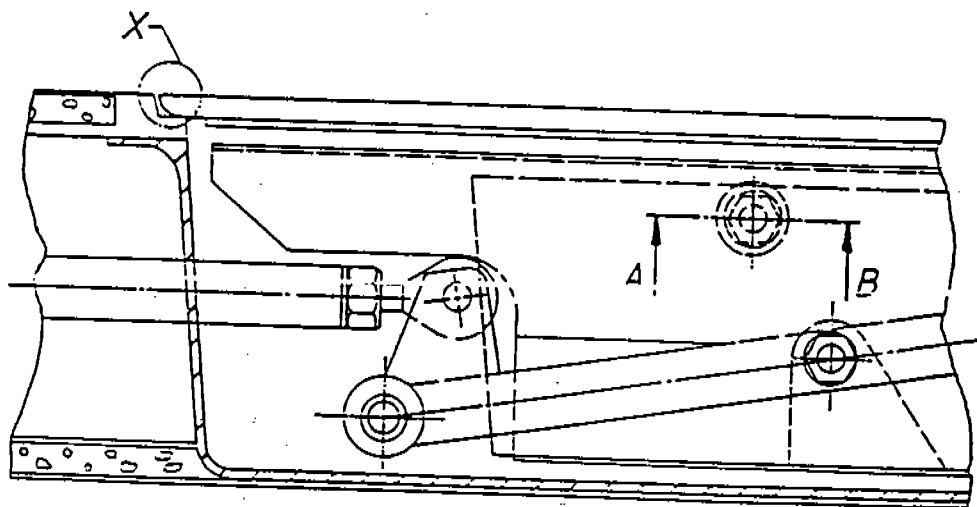
DETAIL X SCALE 1 : 1

Should the gap on the inboard end - between the
cover strip and the inboard edge of the airbrake
housing - be too narrow, the cover strip gets
jammed and makes the extension of the airbrakes
difficult or impossible. Several such incidents
have been reported.

If it is less, enlarge accordingly.
2. Round off the lower edge of the cover strip
on the inboard end as shown on page 03.
3. If not yet accomplished, install a washer
(\varnothing 18 mm/0.71 in.) between the threaded
bushing and the lower airbrake plate as
shown on page 03.
4. With the powered sailplane rigged (wing tip
extensions removed) and airbrakes locked,
check for proper function of the latter:
