## AIRWORTHINESS DIRECTIVE

GFA AD 360

Schweizer SGS 1-26 all models

Inspection/replacement of elevator pushrod

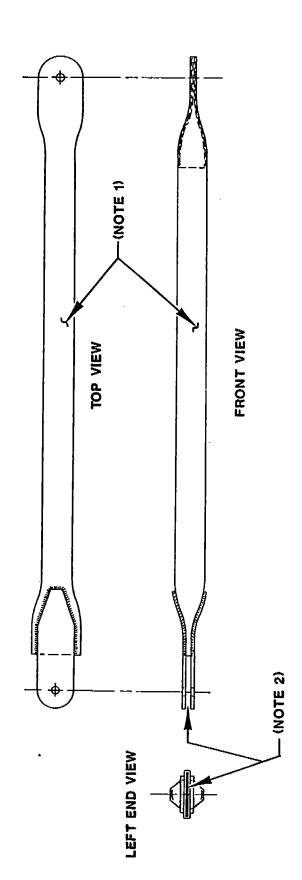
FIGURE 1. ELEVATOR PUSHROD (P/N 26B-12 -1A

- a. Remove cotter pin, nut, washers, and bolts securing push rod at each end.
- b. Remove push rod.
- c. Inspect exterior of push rod for corrosion.  $\underline{\text{No}}$  exterior corrosion is allowed. (Refer to Figure 1.)

- d. If no exterior corrosion is found, use a high intensity light to inspect the push rod interior surface through the open end of the tube. (Refer to Figure 1.) No interior corrosion is allowed.

2. INSPECT INTERIOR SURFACE OF PUSHROD FOR CORROSION BY SHINING HIGH INTENSITY LIGHT THROUGH OPEN END OF TUBE. NO INTERIOR CORROSION IS ALLOWED.

NOTES: 1. INSPECT EXTERIOR OF PUSHROD FOR CORROSION.
NO CORROSION IS ALLOWED.

- e. If any interior or exterior corrosion is found, replace push rod with a serviceable 261478-1 push rod. If there is any question whether interior or exterior corrosion exists, replace push rod or consult the factory.

- f. Inspect attaching hardware for corrosion and general condition. Replace hardware as required.
- g. If no interior or exterior corrosion is found, invert push rod and pour hot linseed oil into open end of tube, until entire push rod is filled with linseed oil. Pour out linseed oil and allow inside surface to dry for one hour.
