GFA AD 362

Security of the charging and lighting coils on the

armature plate assembly.

No. 535-04

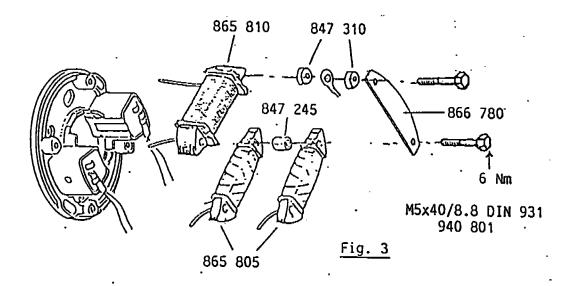
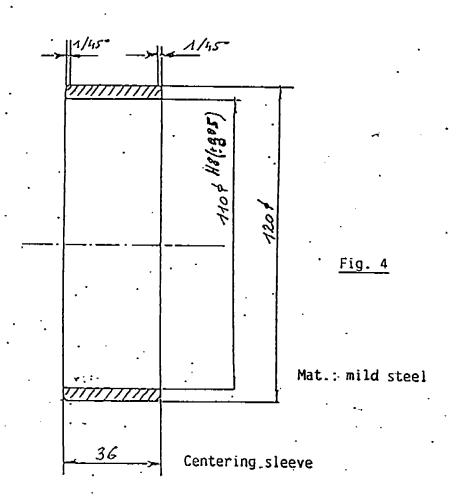
: Caused by creep-behavior of contact surfaces, the screw connection might become loose and thus enables the coils to bend outwards, touching the magnetoring.

- 2) Overhaul of coil fixation: Fig. 3 on page 5
 - 2.1. Clean armature plate ass'y.
 - 2.2. Remove both coils..
 - 2.3. Check coils for signs of wear, damage on holes and contact faces. Exchange as required. Clean contact surfaces to provide good contact.
 - 2.4. Use new hex. screws M5 x 40, 8.8, DIN 931, Rotax p.n. 940 801 instead of previous screws.
 - 2.5. Apply Loctite 221 to screws and contactfaces and slightly fasten screws.
 - 2.6. Place centering sleeve (fig. 4 on page 5) over armature plate, push coils outwards and tighten screws. Screw torque 6 Nm.
 Remark: Centering sleeve absolutely necessary to achieve correct distance between poles and magneto.

Attention: Works to 2.5. and 2.6. have to be performed within 5 min., prior to curing of Loctite.
