# AIRWORTHINESS DIRECTIVE

**TYPES AFFECTED:** ASW 17 - all models, all serial numbers.

**SUBJECT:** Inspection and preservation of mainspar structures

ASW 17  
Technical Note  
No.12

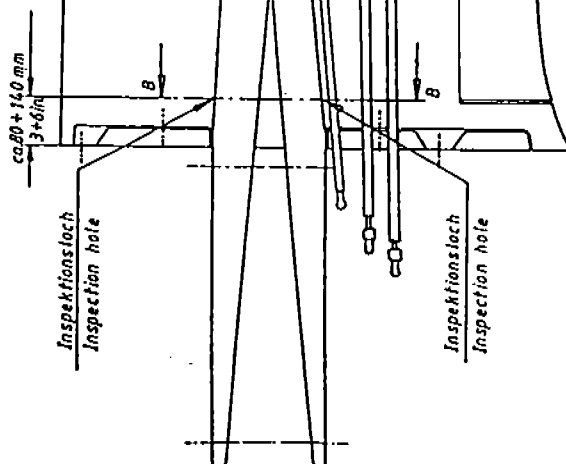
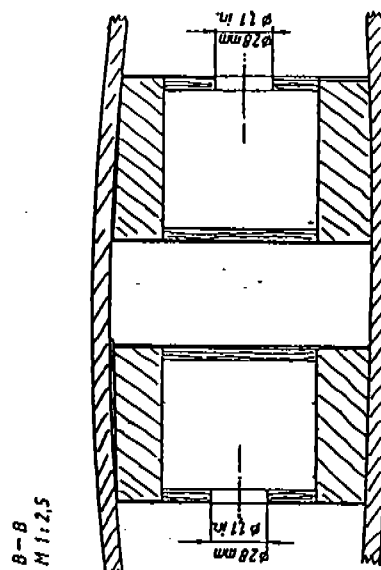
\* Location and dimensions of the inspection holes

- 1.2 For this purpose drill holes of  $\varnothing$  28 mm (see Fig.1) must be made, using a key hole saw (Fig.2). Through these inspection holes the spar inside must be inspected, using an endoscope or a suitable mirror with suitable lighting mechanism (e.g. pocket-lamp bulbs soldered on two stiff, approx. 1 m long wires), and checked for moisture, discoloration and wood-destroying mould fungi; (move the source of light along the spar inside).  
The drill cores which you get with the use of the key-hole saw and which must be correspondingly marked for the purpose of assigning them to the drill holes, must be sent in for a microscopical examination in view of possible fungal damage to one of the institutes listed under "Notes, point 2.". At the front ends of the spar fork and spar tongue the paint must be removed (see Fig.3) and the wood must be checked with the so-called "fingernail" test.

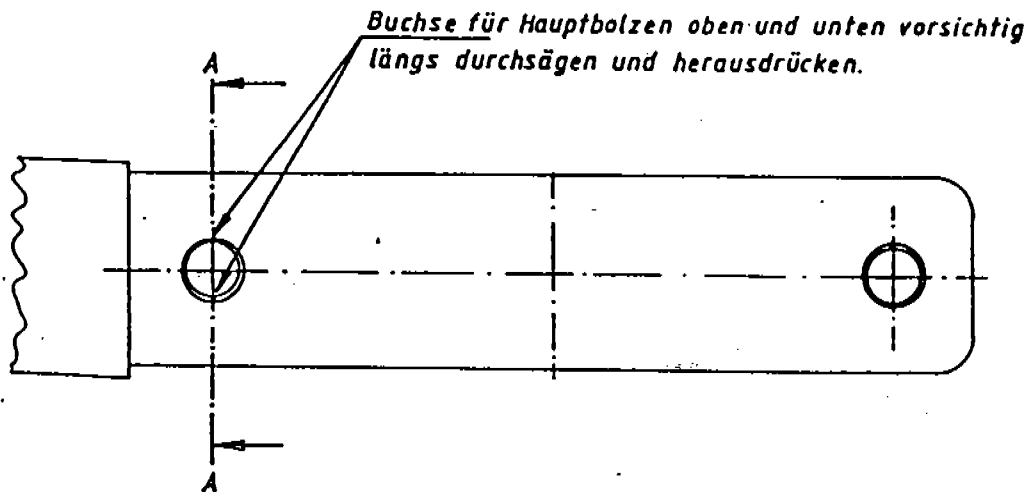
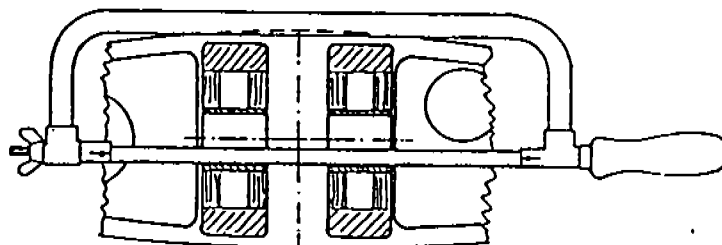
\* Removal of the bushings

2.1 If a swelling up is clearly visible or if there is suspicion that water has penetrated into the spar fork or into the spar stub, the main pin bushing must be removed and the interior between the bushings must be inspected (see Fig. 6).

Carefully saw through the bushings (at the top and at the bottom) in the longitudinal sense and then press them out!
