AIRWORTHINESS DIRECTIVE

- TYPES AFFECTED:** All DG-100 and DG-100 ELAN sailplanes fitted with an all moving tailplane.
- SUBJECT:** Inspection/modification of the main fitting (L4) of the all-flying tailplane.

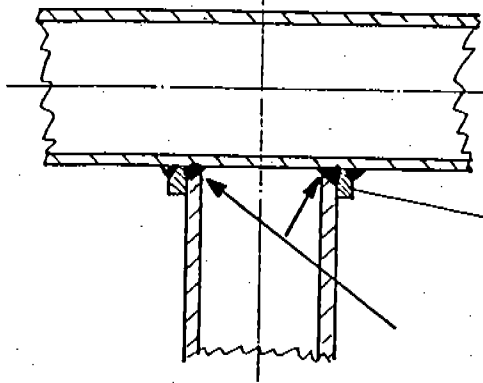
1. INSPECTION FOR WELD PENETRATION

- BACKGROUND** Overseas investigation after the failure of the main fitting of the all flying tailplane has found that the weld penetration was not complete. The manufacturers have issued TN 301/15.

Inspect the welding in the edges inside the tube by means of an Endoscope or an other suitable method.

This welding must be visible inside the tube.

- ACTION REQUIRED** **BEFORE NEXT FLIGHT & EACH TIME THE FITTING L4 IS CHANGED**
- Inspect the main fitting of the all flying tailplane for correct weld penetration.
If the weld is visible inside the tube (see 1) the glider may be returned to service.

If a plastic plug is glued into the tube, the plug is to be removed and to be glued into the tube after the inspection and repair by use of metal adhesive.

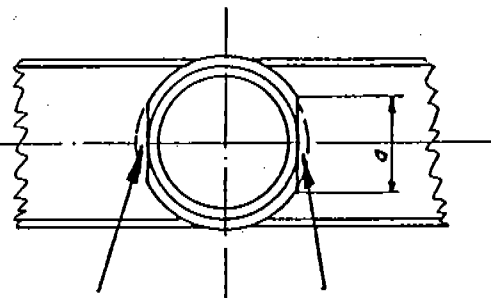
2. REPAIR OF THE FITTING L4

Note: The repair may be executed without removing the fitting from the tailplane.

- a. file off part of the stopring each side
- b. weld the fitting in the region "a". Therefore cover the structure of the tailplane with sheetmetal parts to protect it against heat.
- c. check again (see 1) if the welding is correct and visible from the inside of the tube.
- d. the missing part of the stop ring must not be replaced.
- e. preserve the inside of the tube with a suitable protecting agent for hollow spaces.

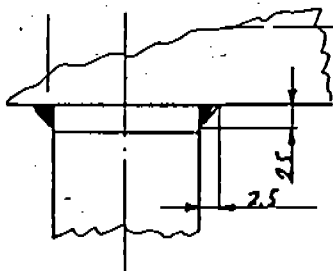
Thickness of welding 2,5 mm (0.1 in.)
