# AIRWORTHINESS DIRECTIVE

THE GLIDING FEDERATION OF AUSTRALIA Inc

## GFA AD 371 Issue 3

| <b>Subject</b> | Ultrasonic Inspection of Main Spar Root End Stub Spigots |

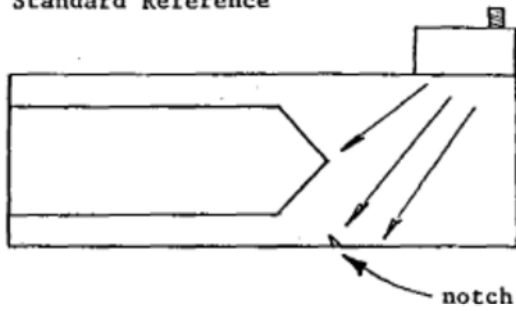
# Standard Reference

Correlation between cracks and reference standard have been such that the standard represents approx .020" deep crack.

Set notch at 80% full screen height
