## AIRWORTHINESS DIRECTIVE

**SUBJECT:** Cracking of elevator actuator.

**TYPE AFFECTED:** ASW 22

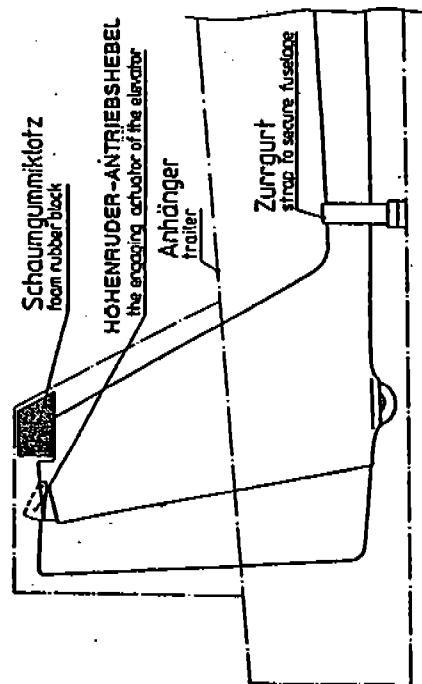
When transported in a glider trailer, care must be taken that the elevator engaging actuator of the glider (on top of the fin) will not be restricted in its necessary free moving by any foam blocks inside the trailer.

If for example such a foam rubber block restricts the free moving of the elevator engaging actuator, with rather long road transports this may lead to a fatigue crack on this part. (See also the drawing on Page 64A of the Maintenance Manual).

The drawing below shows how to cut and locate a foam rubber block. We think it is also useful to have a strap anchored in the trailer floor in order to secure the tail boom in front of the fuselage-fin-transition. In any case be sure that the elevator engaging actuator is free moving. Even with the stick full back, full upwards deflection of the elevator engaging actuator must be possible.

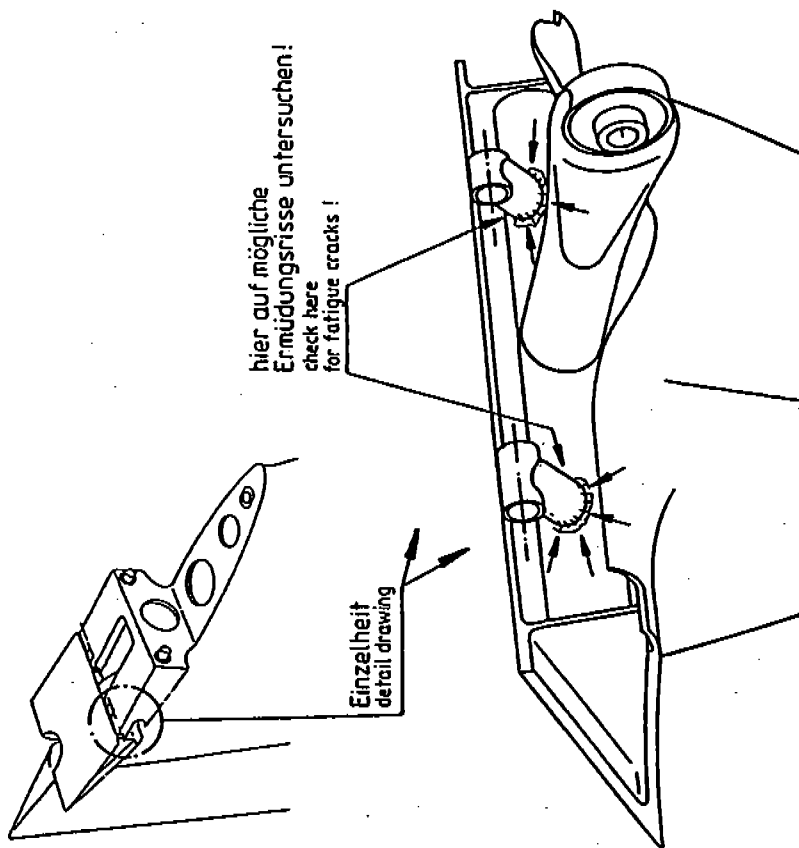
20. The elevator engaging actuator (on top of the fin) must be inspected for cracks at the locations which are shown below in the drawings. If it can be guaranteed that the welding seam can be minutely inspected all around the tube, e.g. by the aid of a small angular mirror, then the elevator engaging actuator need not be dismounted for this purpose.

Also the glider trailer in which the glider is transported, must be checked in accordance with the Flight Manual chapter VI.4 "Road Transport" (page 63) and where necessary, must be modified.
