**AIRWORTHINESS DIRECTIVE**

**SUBJECT:** Damage to aileron quick connect and subsequent control circuit jamming.

**TYPE AFFECTED:** LS 7

**DOCUMENTATION:** Rolladen Schneider Technical Bulletin No. 7004.

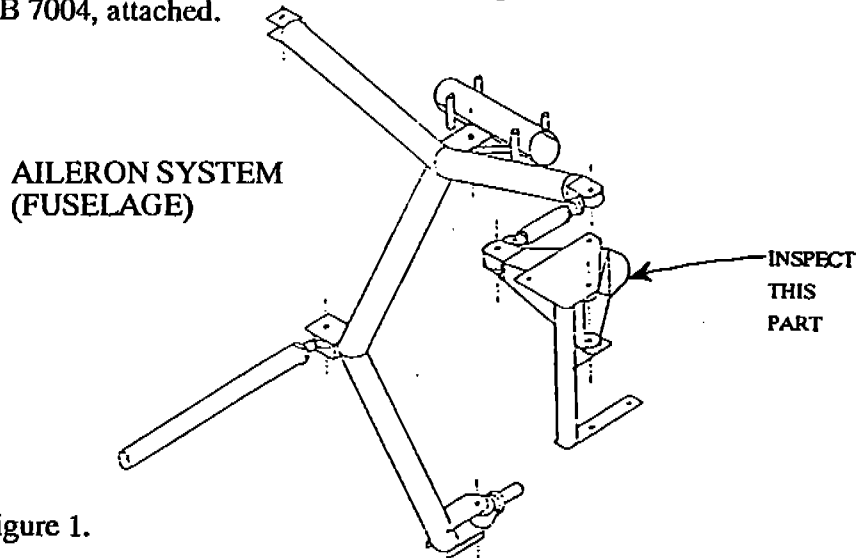
Figure 1.

**BACKGROUND:** In one case the aileron quick connect in the fuselage was damaged during rigging and the aileron circuit became jammed.

**ACTION REQUIRED:** 1. Before next flight inspect the quick connect mechanism in the fuselage, as shown in Figure 1, for straightness in accordance with TB 7004, attached.

2. Enlarge the fuselage cut out in accordance with drawing 4I-86, attached, to prevent jamming of the aileron circuit should the quick connect be accidentally damaged.
