**AIRWORTHINESS DIRECTIVE**

- SUBJECT:** Possible incorrect assembly of the aileron drive mechanism.
- TYPE AFFECTED:** Jantar 2A and Jantar 2B
- BACKGROUND:** When the glider is de-rigged it is possible for the aileron to become dislodged from its hinges. When re-installing the ailerons it is possible to install the aileron drive incorrectly by inserting the lever end above the guide instead of into it. Incorrect assembly can only be detected by the change in aileron deflection and operating noise of the aileron. Stick travel is not restricted by incorrect assembly of the aileron.

Ref: Inspection of the correct installation of aileron control system levers in the wing guides.

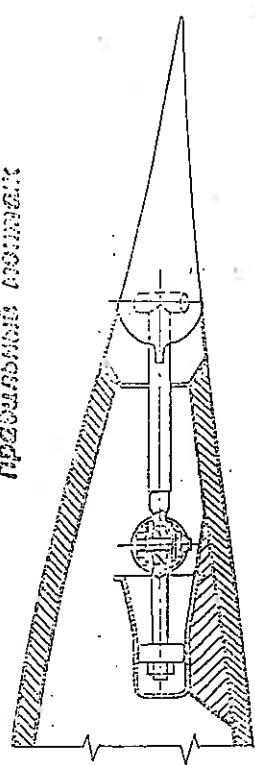
The sketches Fig. 1 and Fig. 2 show the correctly and incorrectly assembled aileron control levers.

montaż prawidłowy  
correct assembling  
richtige Zusammenbauung  
правильный монтаж

5.1. When assembling the inner aileron pay a special attention to insert correctly the ends of control levers into the "pockets" of the guide housing.  
After assembling check the aileron deflections to be correct.

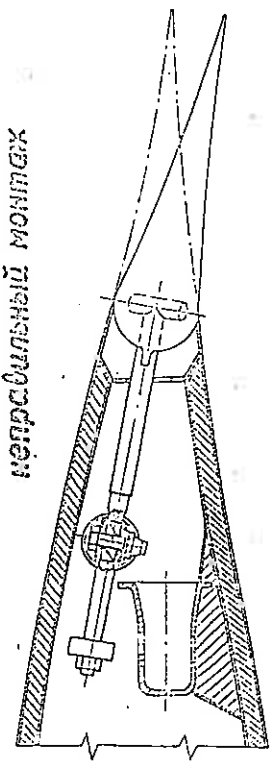
Fig. 2

In the operation the case of incorrect assembling of aileron control system occurred. It depended on the fact that the lever end has been inserted above the guide housing instead of to be inserted into the "pocket" formed by the guide housing.

The incorrect aileron assembling is monitored by the noisy operation and changed deflection range.

The restriction in the stick movement does not appear, so the fault can be not recognized by the pilot.

wadliwy montaż  
incorrect assembling  
falsche Zusammenbauung  
неправильный монтаж

- DOCUMENTATION:** PZL-Bielsko Bulletin BE-039/90.
- ACTION REQUIRED:**
1. At each DI the ailerons should be visually checked for correct assembly as shown in figures 1 and 2 of the PZL-Bielsko Bulletin BE-039/90 which forms part of this AD.
