AIRWORTHINESS DIRECTIVE

TYPE AFFECTED: IS28b2, IS30 and IS32.

SUBJECT: Cracking of rudder pedals.

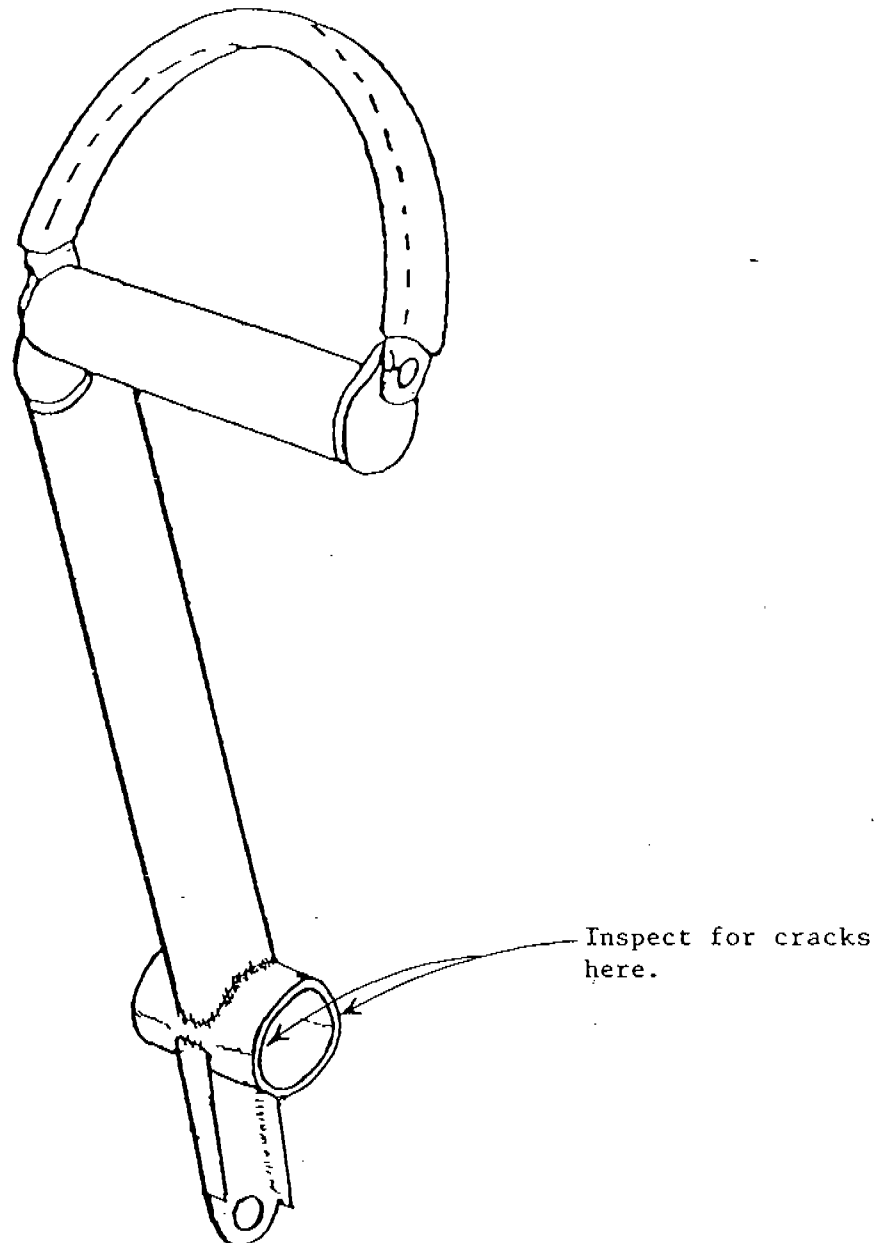
Figure 1.

BACKGROUND: While performing spin training the front rudder pedal of an IS28b2 failed across the bearing support tube. Recovery was affected by the rear pilot.

ACTION REQUIRED: Before next flight and at each Form 2 inspect the front rudder pedals for cracks as shown in figure 1. Use dye pentrant.

Any cracks found must be repaired by welding and the tube reamed to suit the bronze bushes. Welding must be done by an approved welder. If repair is not practical the part must be replaced.
