## AIRWORTHINESS DIRECTIVE

**TYPE AFFECTED:** ASK 13

**SUBJECT:** Inspection of the root rib dive brake belcrank support brackets and adjustment of the dive brake overcenter.

| SHEET:<br>2 of 2 | ASK 13<br>Technical Note<br>No. 14 | Alexander Schleicher<br>GmbH & Co.<br>Segelfluggzeugbau<br>D-6416 Poppenhausen |

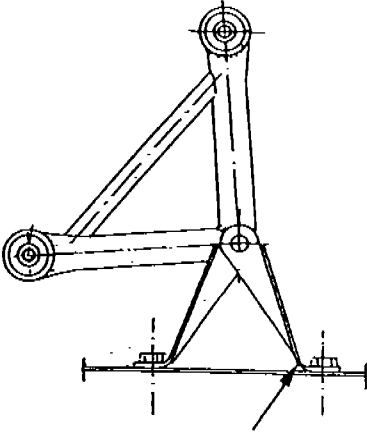
Material & drawings:

On some gliders of the model ASK 13 the bearing brackets of the airbrake control circuit have broken at the wing root rib. The failure was caused by too high toggle forces which resulted from a wrong adjustment of the toggle in the airbrake control circuit.

1. Carefully inspect the bearing brackets of the airbrake control circuit at the wing root ribs as well as the root ribs themselves for damage, cracks etc. In case of doubt the paint must be removed off the bracket. In most cases the breaks were found at the bottom of the front bearing bracket; refer to the drawing on Sheet 2 of this TN !  
Where damages at one bearing bracket are found, this part must be exchanged; where a root rib is damaged, it requires repair.

2. Check the toggle force as described under Point 3.) and where necessary adjust.
3. Adjustment Instructions For Airbrake Toggle
  - 3.1 Undo the airbrake return spring at the front operating lever in the cockpit.

- 3.2 The airbrake toggle - each side separately - must be adjusted such that a force of approx. 3 to 4 daN is obtained at the front airbrake operating lever when measured from above (measurement distance from the pivot point of the operating lever towards the hand grip = 300 mm).

- 3.3 Adjustment of the toggle force is done by turning in or out the adjusting heads in the fuselage. If the correct adjustment values cannot be achieved here, the thickness of the airbrake stop blocks inside the wings must either be increased or cut back.
