AIRWORTHINESS DIRECTIVE

TYPE AFFECTED: ASW 24

SUBJECT: Modifications for the issue of an Australian Certificate of Airworthiness.

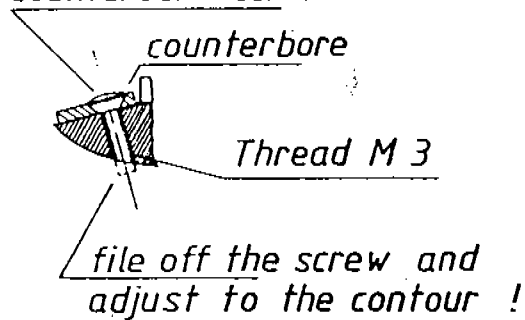
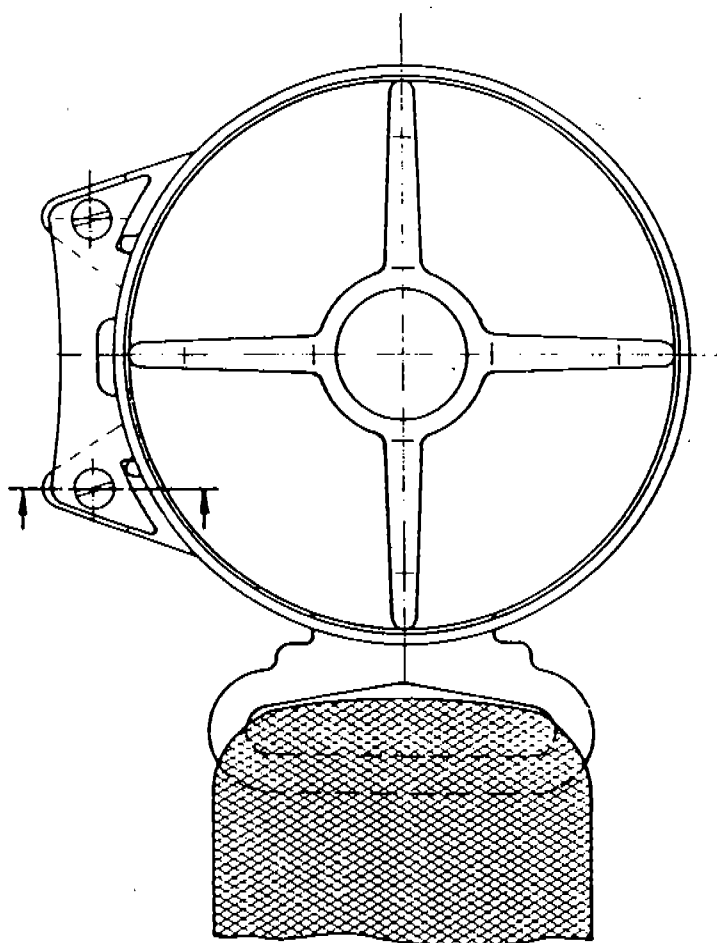
Figure 1.

Countersunk screw M3 x 10 DIN 964 (use 'Loctite' to secure the screw)

The Gadringer rotary lock harness must be modified by installing 2 screws as shown in figure 1 to prevent separate disconnection of the shoulder straps.
