## AIRWORTHINESS DIRECTIVE

**TYPE AFFECTED:** ASW 24 E

**SUBJECT:** A) Securing of the engine support bracket screws.  
B) Replacement of the lower support bracket of the gas strut near the screw jack.  
C) Supplement to the Maintenance Manual.

**DOCUMENTATION:** ASW 24 E Technical Note No 2.

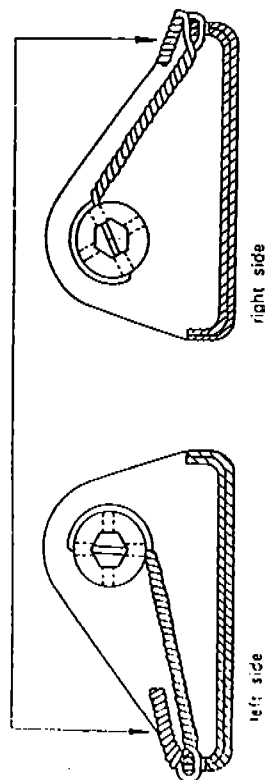
Fig. 1:

| SHEET:<br>2 of 4 | ASW 24 E<br>Technical Note<br>No. 2 | Alexander Schleicher<br>Segelflugzeugbau<br>D-6416 Poppenhausen |
|---|---|---|
| <p><u>Reason:</u></p> <p>Ad A): Some cases with the motorglider ASW 24 E have been reported where the cylindrical screws M10 at the engine support bracket have backed off (see Fig 2.2-5, item 29, on Page 2.11 Maintenance Manual).</p> <p>Ad B): Some cases with the motorglider ASW 24 E have been reported where the cylindrical screw M6 at the lower support bracket of the gas spring near the screw jack has broken (see Fig 2.2-7, item 53, on Page 2.13 Maintenance Manual).</p> | | |

| SHEET:<br>2 of 4 | ASW 24 E<br>Technical Note<br>No. 2 | Alexander Schleicher<br>Segelflugzeugbau<br>D-6416 Poppenhausen |
|---|---|---|
| <p><u>Action:</u></p> <p>A-1) If the cylindrical screws M10 at the engine support bracket (see Fig. 2.2-5, item 29 on Page 2.11 Maintenance Manual) have not backed off, they must be secured with a thicker locking wire <math>\phi</math> 1.4 mm as to be seen in Fig. 1 under point "Material and Drawings".</p> <p>A-2) If the cylindrical head screws M10 are loose or if the locking wire is damaged, in addition also the spacer bushing in the swivelling engine support arm (see Fig. 2.2-7, item 49 on Page 2.13 Maintenance Manual) must be checked for smoothness of operation. If the spacer bushing is seized, its clearance must be re-established by reaming the <math>\phi</math> 13 mm bore in the swivelling engine support arm larger by ca. 0.05 mm. Where necessary, the bushings must be replaced; in that case proceed as per Action A-1).</p> <p>B-1) Back off the cylindrical screw M10 at the lower support bracket of the screw jack by 1/4 turn (see Fig. 2.2-7, item 98, on Page 2.13 Maintenance Manual) and then carefully grease the lower support of the screw jack.</p> <p>B-2) Remove the lower support bracket of the gas spring (see Fig. 2.2-7, item 54, on Page 2.13 Maintenance Manual) and send it back to SCHLEICHERS for modification of the part. This action is unavoidable because this part was individually adapted to each motorglider. According to Fig. 2 under "Material and Drawings" the modified gas spring support bracket then has to be refitted. Instead of the cylindrical screw M6 now a dowel pin M6 (AS P/N 248.67.00731) is screwed into the housing of the screw jack and is secured with LOCTITE 638 and Activator 764. The bushing for gas spring/screw jack support bracket (see Fig. 2.2-7, item 55 "Drehteil f. Gasfeder/Ausfahrspindel unten", on Page 2.13 Maintenance Manual) is no longer applicable.</p> | | |

Ad A) Locking wire  $\phi 1.4$  mm,  $\approx 1$  m and possibly spacer bushing for swivelling engine support arm (AS P/N 248.67.0009).

Secure the locking wire ends by 6 turns minimum !
