**GFA AD 408**

**GFA AIRWORTHINESS DIRECTIVE**

**TYPE AFFECTED:** Grob G 109B from serial number 6200.

**SUBJECT:** Drain holes in the elevator and trim tab.

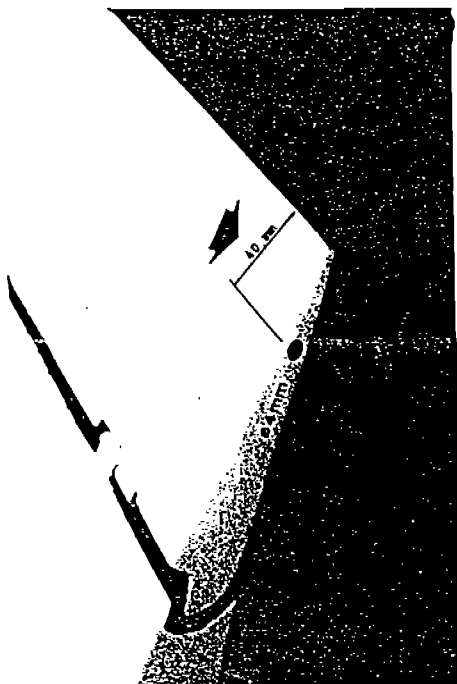
6  $\phi$  4 mm

7  $\phi$  4 mm

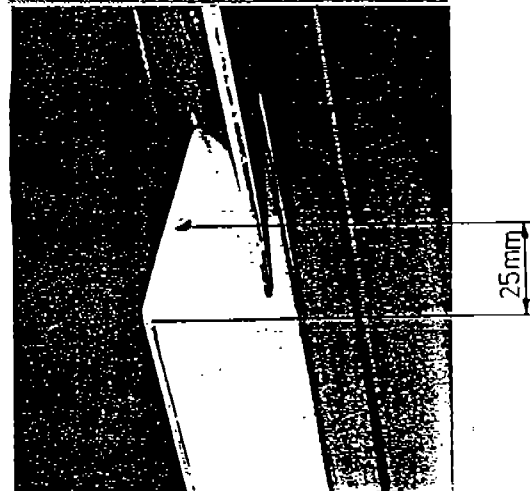
8  $\phi$  4 mm

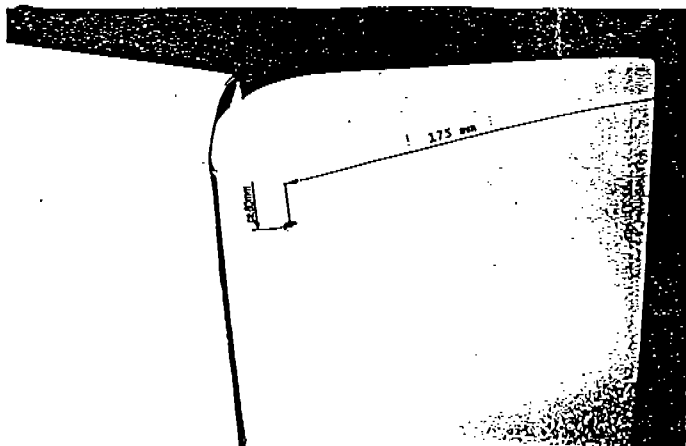
1, 4  $\phi$  6 mm

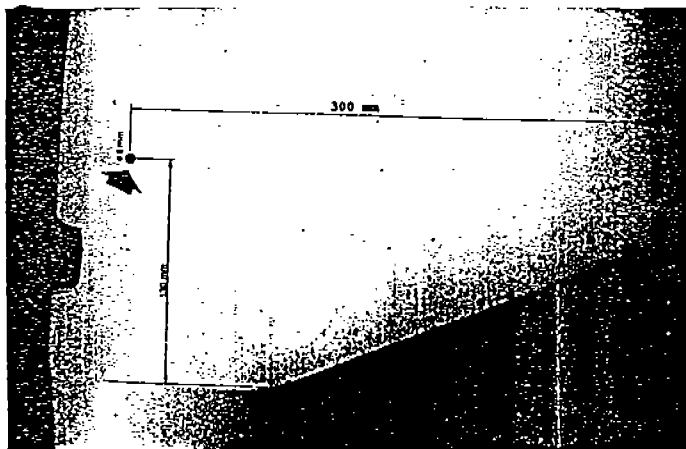
2, 3  $\phi$  6 mm

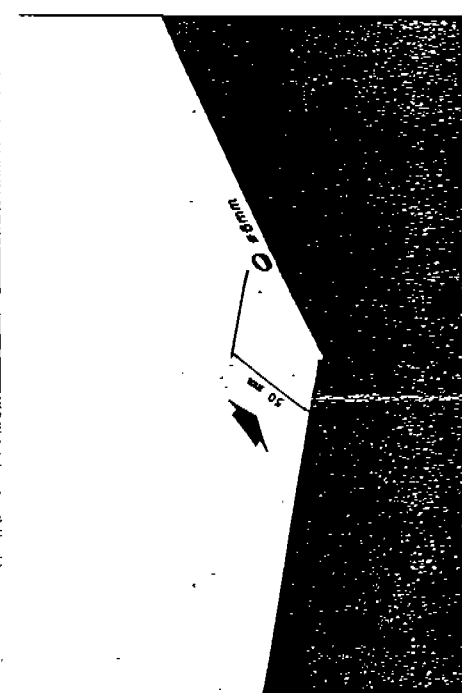
5  $\phi$  6 mm
