**GFA AD 424**  
(ISSUE 1)

## GFA AIRWORTHINESS DIRECTIVE

**TYPE AFFECTED:** KR-03A Puchatek. Serial numbers 01-01 to 03-25.

**SUBJECT:** Replacement of the pivot for the rudder drive crank and reinforcement of the rear skid mount.

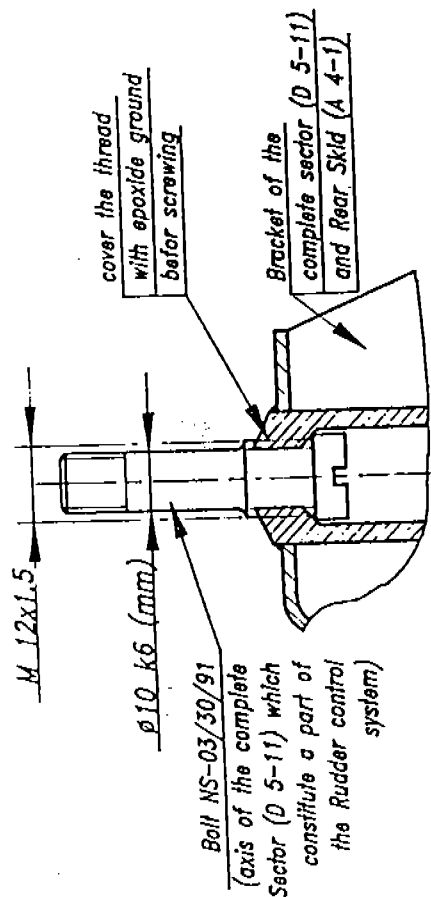
1. Reason of Bulletin's introduction. The present Bulletin aims removing of designe faults of the bolt, being an axis of the Complet Sector.  
Simultaneously, taking into considoration glider operators' proposals as well as recommendations of the Polish Airworthiness Authority the Bulletin introduces reinforcement of the rear skid's fixing structure.

| <p>4.2. Disconnect the Complete Cable (D5-8) and Special Push Rod (D5-12) from the Complete Sector (D5-11)</p> <p>4.3. Turn the fuselage upside-down (by 180°) and place it on supports.</p> <p>4.4. Following the below mentioned procedure and the sketch, replace the bolt with the new one without dismounting the Complete Sector's (D5-11) fitting and Rear Skid (A4-1) from the fuselage structure.</p> <p>The old bolt should be removed by reaming with a drill of dia. 6 mm starting from the rear skid side. The hole</p> | | |
