## GFA AIRWORTHINESS DIRECTIVE

**TYPE AFFECTED:** T59 Kestrel all models.

**SUBJECT:** Corrosion of the elevator pushrod in the fin.

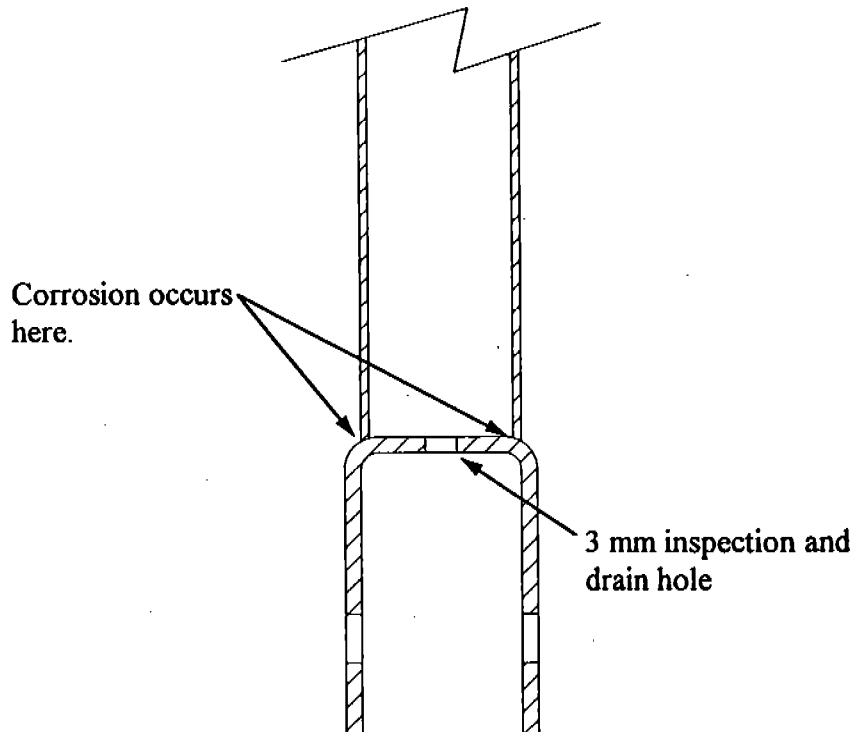
**FIGURE 1 PUSHROD END**

**BACKGROUND:** Several instances have been reported to GFA and Slingsby Aviation of corrosion in the lower end of the vertical elevator pushrod in the fin due to water entering through the witness hole for checking the engagement of the rod end thread.

The pushrod should be inspected by removing the rod end (mark the rod end so that it can be reinstalled in the correct place), drilling a 3 mm hole in the bottom of the pushrod (see Figure 1) and shining a light through the hole and inspecting from the other end.

If no corrosion is found a small amount of corrosion inhibiting paint should be poured into the pushrod and sloshed around to evenly coat the interior of the tube and the excess paint drained out. The hole drilled in the bottom of the tube must be left open as a drain hole.

After repair the interior of the tube must be painted and a drain hole installed as above.
