## GFA AIRWORTHINESS DIRECTIVE

- TYPE AFFECTED:** ASH 26 E up to Serial Number 26134.
- SUBJECT:** Inspection and possible replacement of the rotor cooling fan.
- BACKGROUND:** Service experience has shown that cracking of the cooling impeller is possible.

| <b>GFA AD 491</b> | <b>ISSUE: 1</b> | <b>7 October, 1998</b> | <b>Page 2 of 5</b> |

**ASH 26 E**Prüfung des Lüfterrads der Luftinnenkühlung  
*Checking the fan of the rotor cooling air system***Alexander Schleicher**

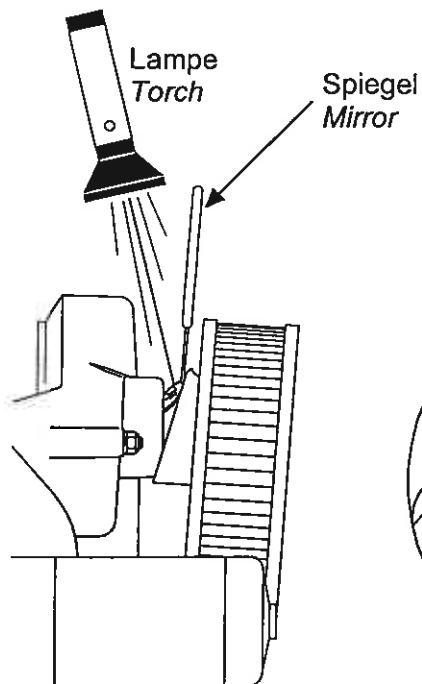
4. Schelle (4) des Kühlluftfilters (5) lösen.
5. Öltank vorsichtig nach hinten schieben.
6. Kühlluftfilter (5) ebenfalls so weit wie möglich nach hinten schieben und mit einem Schraubendreher den Gummifansch am Filter wegdrücken, damit mit einem Spiegel, wie in Fig. 3 dargestellt, das Lüfterrad im Inneren des Lüftergehäuses kontrolliert werden kann.
4. *Undo the clamp (4) at the rotor cooling air filter.*
5. *Move oil reservoir carefully to the back.*
6. *Move rotor cooling air filter (5) backwards, as far as possible and press the rubber flange of the filter to the back by means of a screwdriver, as shown in fig. 3, so that the fan inside the cooling air fan assembly can be inspected.*

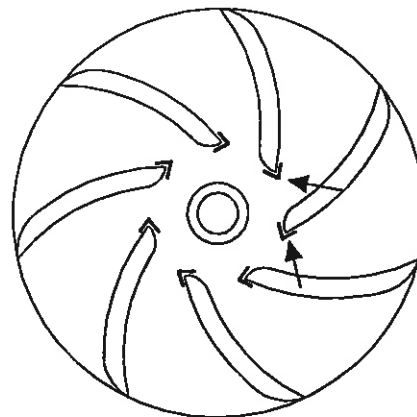
7. Lüfterrad an den in Fig. 4 gekennzeichneten Stellen kontrollieren, ob an den Lüfterradflügeln Risse vorhanden sind. Kurze, weiße Verfärbungen in diesen Kanten sind noch tolerierbar.
7. Check fan blades at the position marked in fig. 4 for cracks. Short, white discoloration at these edges is tolerable.

- If cracks are found or after 16 hours of engine operation with no cracks the cooling fan assembly must be replaced before next engine operation.
- If an engine with a 32 mm pulley and no cracks in the impeller remains in service then the maximum engine speed is limited to 6900 RPM. This must be placarded next to the ILEC engine control unit.
