## T HE GLIDING FEDERATION OF AUSTRALIA

**AD 493**

## **GFA AIRWORTHINESS DIRECTIVE**

IS-28B2 and IS-30

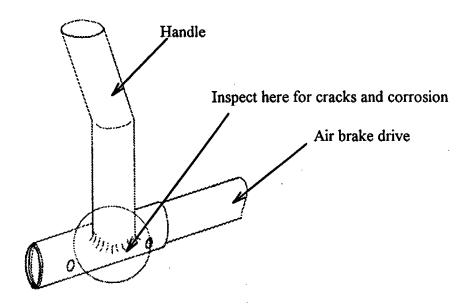
## Sketch of affected area for closer inspection

Before next flight inspect the airbrake handles for cracks as shown in figure 1. Remove any rust for proper inspection. Use a magnifying glass and if in doubt use dye penetrant. If any cracks are found the modification according to figure 2 must be performed prior to the next flight. Otherwise the modification must be performed before the next Form 2 inspection is completed.

The modification must be performed by a certified welder for aircraft. Corrosion is a problem at the handle of the airbrakes. Sweat is very likely to accumulate at the bottom of the handle leading to corrosion and cracks in the affected area. Thorough protection against corrosion after welding is essential for the modification of the airbrake handle.
