AD 495
(ISSUE 1)

GFA AIRWORTHINESS DIRECTIVE

TYPE AFFECTED: IS-32A

SUBJECT: Inspection of the airbrake handle for cracks and corrosion.

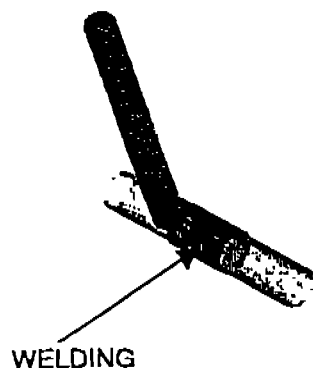
Failure of an air brake control handle at the welding seam.

- Dust the two air brake control handles; if the result is not satisfactory, clean with a soft cloth.
- Inspect the welding and the adjacent area.

If any suspicions exist, use a penetrant dye.
If a crack is detected to one of the two control handles, stop the glider from flight and order new handles to IAR - Brașov.
