GFA AIRWORTHINESS DIRECTIVE

TYPE AFFECTED: AMT 200 Super Ximango.

SUBJECT: Position of Fuel Pump Placard.

Title: FUEL PUMP - POSITION OF FUEL PUMP PLACARD.

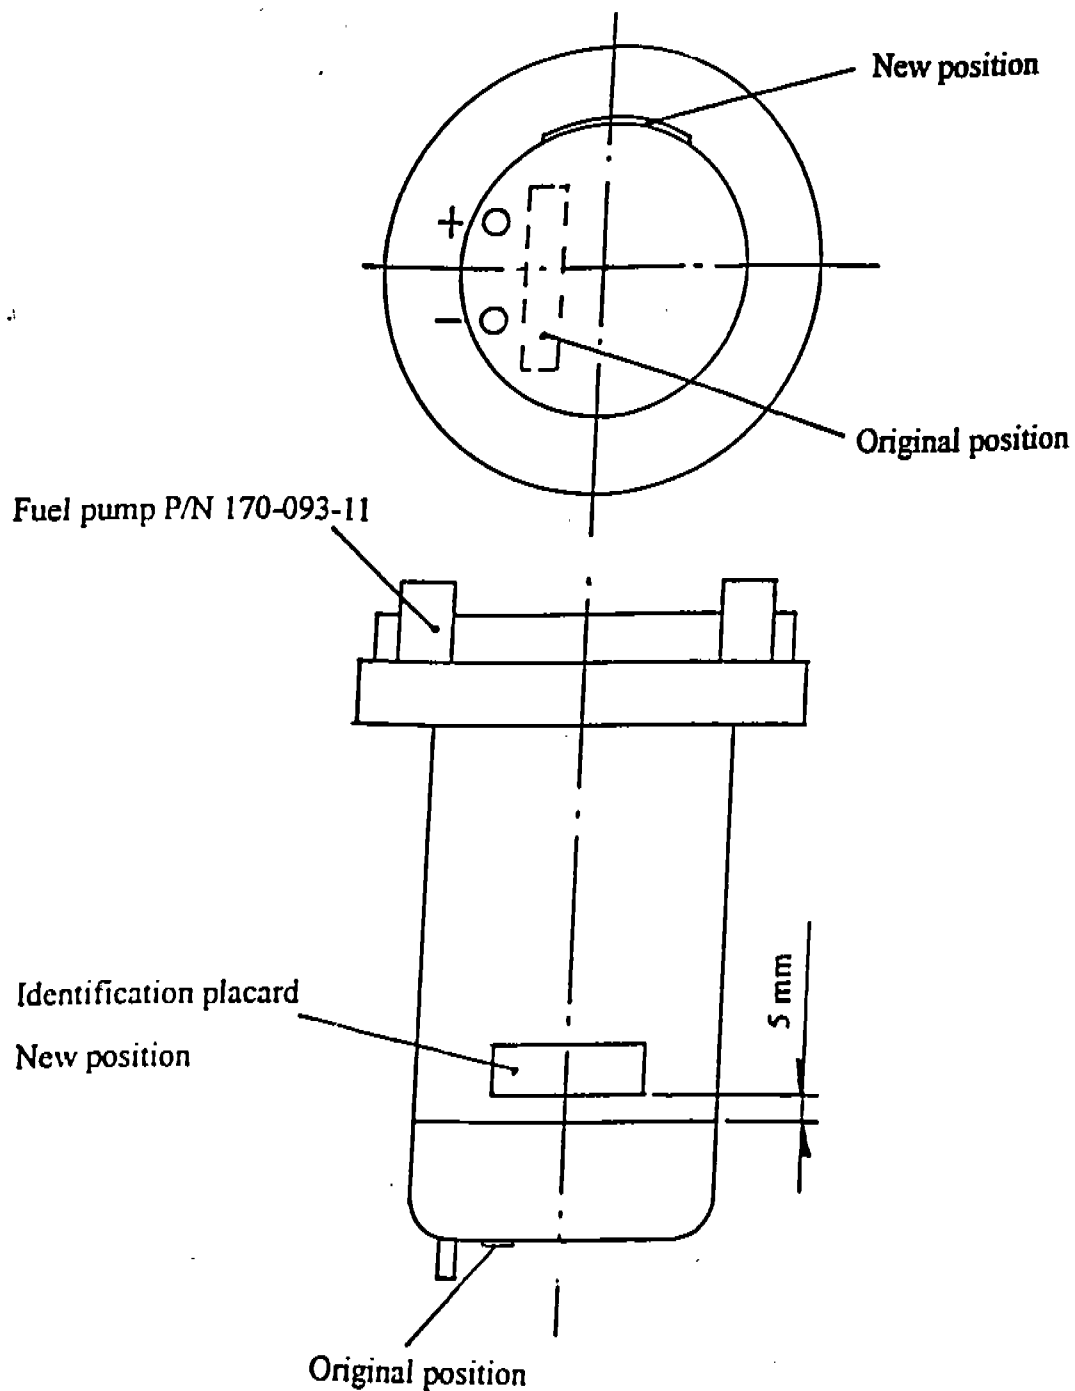
Figure #1

To avoid a possible fuel pump P/N 170-093-11 malfunction due to aluminium identification placard displacing from original position, causing a short circuit in the electrical poles.

- 2.3 Sand lightly the glued surface of the placard to remove old glue. Clean the placard from dirt and dust.
- 2.4 Bend lightly the placard to match it with the curvature of the fuel pump housing (see figure #1 in the annex).

- 2.5 Prepare epoxy resin (24 hours epoxy glue - CIBA GEIGY or similar) and glue the identification placard on the top of the pump housing 5mm below the edge of the metal part of the housing (figure #1 in annex).
