GFA AD 514
(ISSUE 2)

GFA AIRWORTHINESS DIRECTIVE

TYPE AFFECTED: LS-7, all models, all serial numbers.

SUBJECT: Obstruction of emergency canopy jettison.

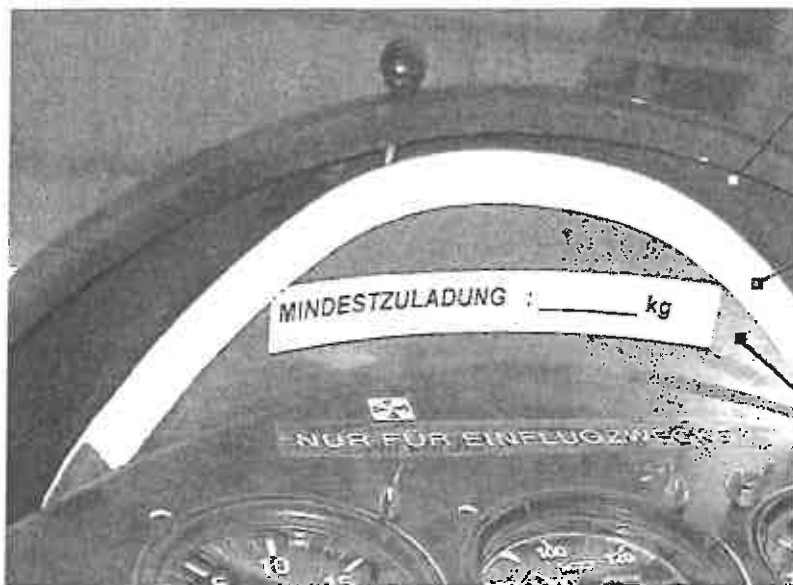
Deflector with edge protector:

Reason: A deflector on the upper instrument panel edge avoids possible jamming of the instrument panel between the canopy mounted panel cover after actuation of the canopy emergency jettison.

When the plane is already equipped with a reflector according to TB 6036, this should be shortened by 10 mm (0.4 in) and be covered with an edge protector. Details and view see working instruction.

1. Drill blind rivets. If need be, unscrew upper instruments (Hexagon head 2.5 mm und ratchet with 7mm socket) and place them on top of the second row.
2. Mark new fixing holes 10mm (0.4 in) offset from originals and drill. This enables to use the existing holes at the instrument panel edge.
3. Shorten straight edge of deflector by 10 mm, soften edge and paint black. Maximum depth of deflector after trimming is 100 mm (3.94 in).
4. Rivet deflector back to top of instrument panel, facing towards the pilot (Blind rivets $\varnothing 4\text{mm} \times 6.5$, large washers $\varnothing 4.3 \times 12 \times 1\text{mm}$ DIN 9021-St).
5. Push edge protector (as long as instrument panel allows) onto deflector edge.

Should the instrument panel cover be too short to allow the protector to fit underneath, contact manufacturer stating model and serial number.
