THE GLIDING FEDERATION OF AUSTRALIA

GFA AD 524
(ISSUE 1)

GFA AIRWORTHINESS DIRECTIVE

- TYPE AFFECTED:** Blanik L 13, all variants and serial numbers.
L 13 SW, L 13 SL and L 13 SEH Vivat, all variants and serial numbers.
- SUBJECT:** Tail-Fuselage Attachment Fitting.

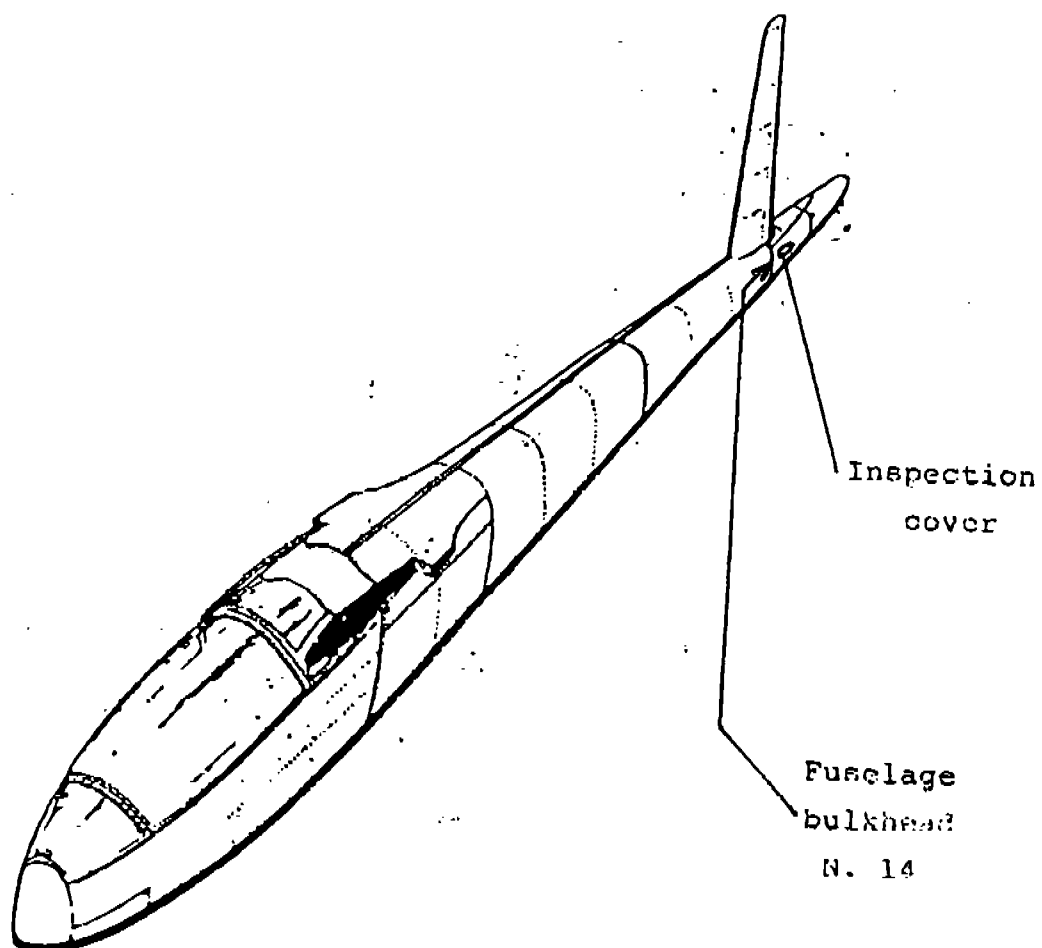
Fig. 1

1. Remove the oval cover located on the LH side of the fuselage, under the horizontal stabilizer.
2. Test the material of the attachment fitting P/N A 102 021 N as follows:
 - a) Conductivity measurement by means of eddy currents:
 - Recommended measurement frequency: 60 kHz
 - Probe diameter: not exceeding 15 mm
 - Measuring contact point: lower milled surface of the component, between the rivets (see Figs 1 and 2).

Measuring contact point

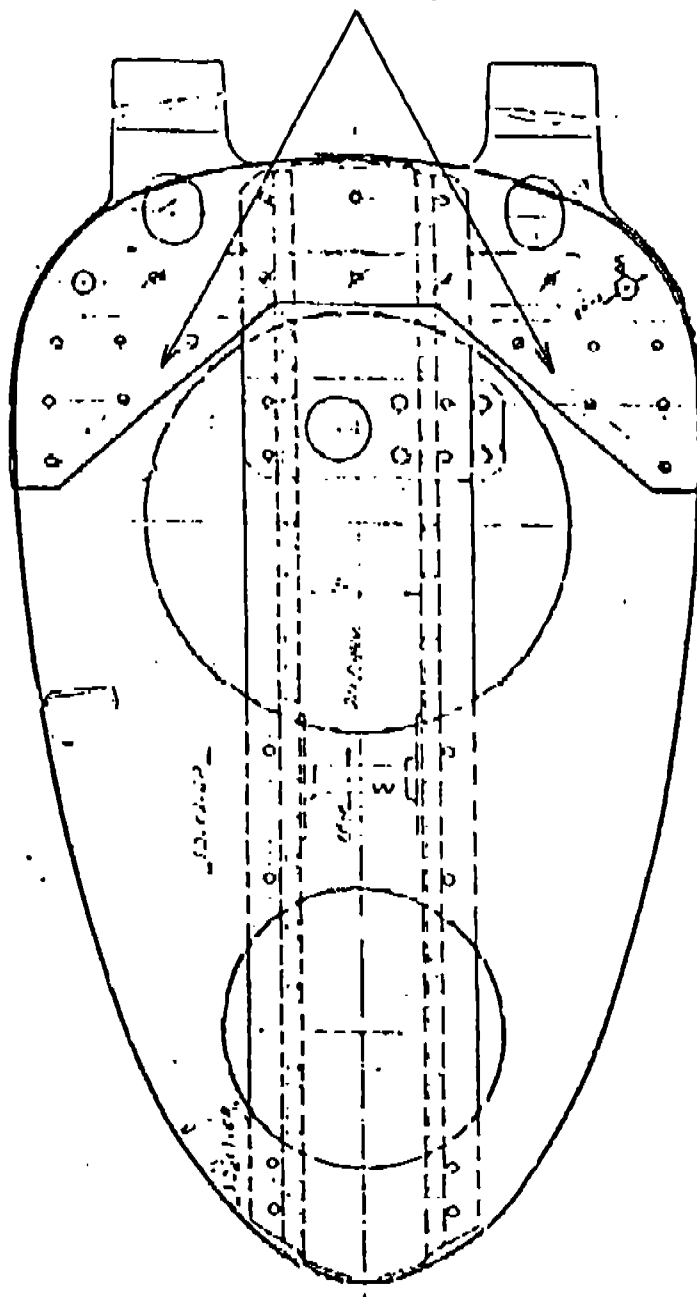
Fig. 2

Fuselage bulkhead N. 14 with attachment fitting P/N
A 102 021 N
