GFA AD 535
(ISSUE 2)

GFA AIRWORTHINESS DIRECTIVE

**Airworthiness
Directive
2000-074**

Engine mount - Cracks in the engine mount structure

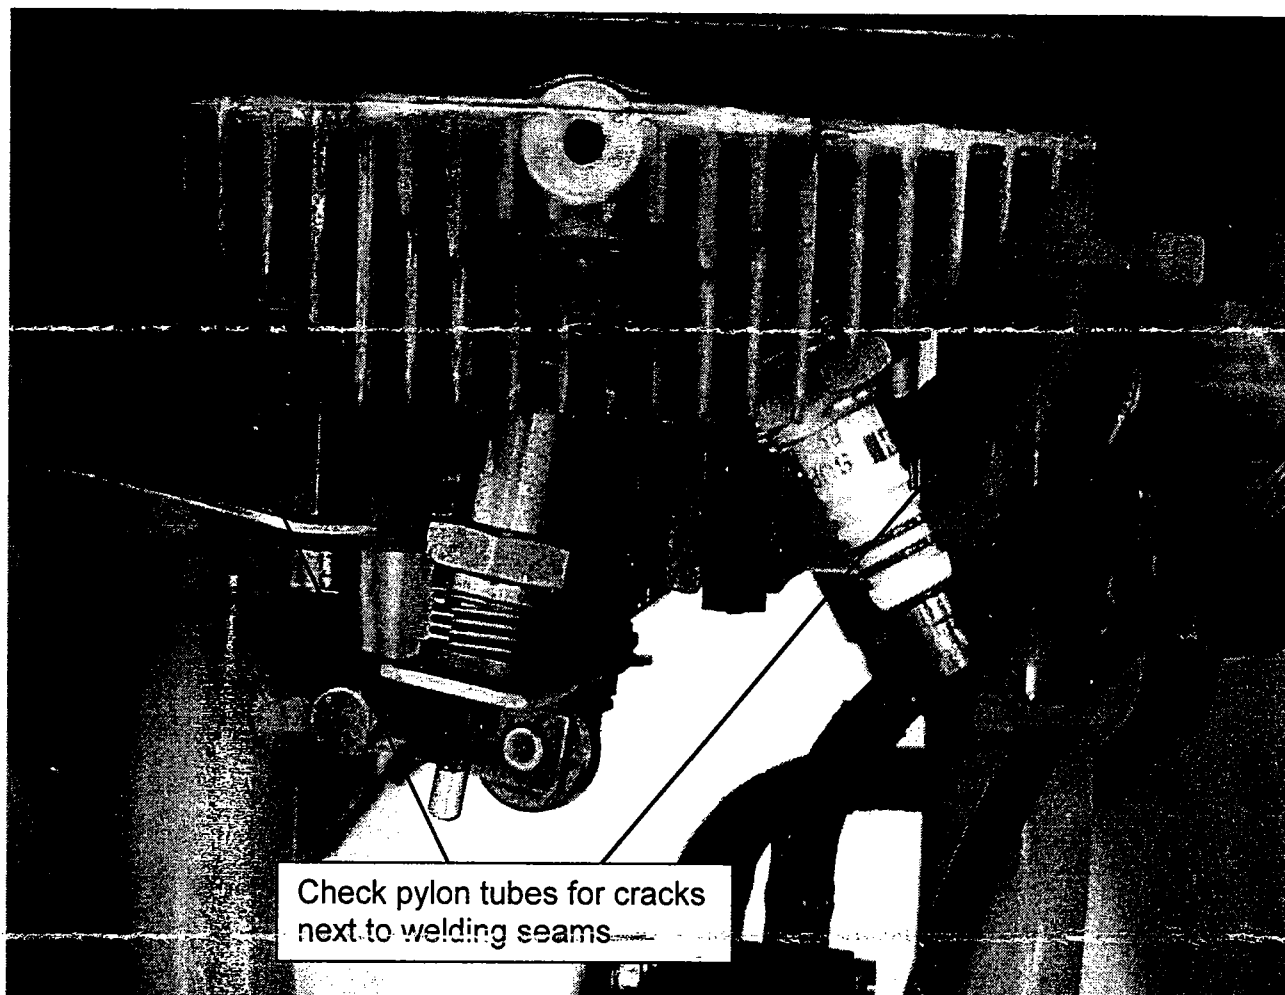
front view of pylon

On some pylons cracks in the steel tubes next to welding seams were found - the material used within a certain period was not sufficiently resistant against vibrational loads. Such pylons must therefore be replaced or repaired.

Check pylon tubes at the welding seams of the lower engine mount for cracks
- see also photographs enclosed.
If damage (cracking) is found, the pylon must be removed and returned to the manufacturer.

The pylon is to be replaced in accordance with the working instruction found on page 3 of the appendix to this TN.
