**GFA AD 538**  
(ISSUE 1)

### GFA AIRWORTHINESS DIRECTIVE

**TYPE AFFECTED:** KR-03A Puchatek, serial numbers 01-01 to 01-06, 02-01 to 02-15, 03-01 to 03-24, 04-01 to 04-20 with airbrake arms No. AB.20.030.00.13 (LH)/23 (RH).

**SUBJECT:** Cracking of airbrake central actuating arms.

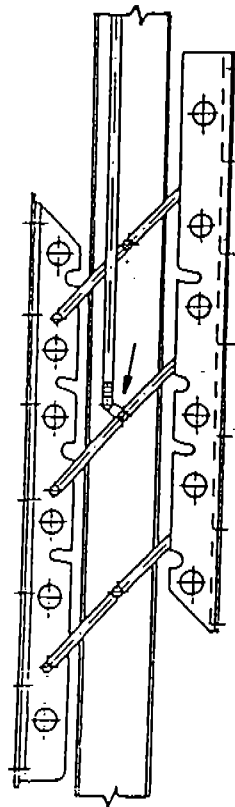
1. The reason for the Bulletin's introduction.  
On the KR-03A glider of s/n 03-22 being operated in the USA, a crack appeared on the air brake's left arm used for the extension of the air brake. The reason for this was probably an incorrect welding and poor anticorrosion protection. The present Bulletin aims to make an inspection action regarding the a/m arms and, in consequence, it protects against unfortunate events.

4. Description of the work to be done.  
Check out the condition of the extension arms of the air brake in the area of the axle and brake's lever with regard to the cracks and corrosion appearance (see sketch).  
Make the visual inspection using an enlargement (5x) and other available non destructive tests having dismantled air brake's plates.

arrows show places to be inspected

If any cracks are detected the arm must be replaced with no exemption. In such a case contact the manufacturer of the KR-03A glider in order to get the a/m arms (acc. to the new design) and instruction to carry out the arm's replacement.  
The operators of the gliders covered by the warranty will be supplied with the arms free of charge, however remaining ones will be charged.  
If the corrosion spots are noticed on the arms the rust should be removed and then the anticorrosion protection is to be applied. The inspection is to be repeated periodically either each 50 flying hours or 6 months whichever comes first.  
When making wing's repairs for which fabric has to be removed it is recommended to replace the arms with the ones of the new design.
