**GFA AD 541**  
(ISSUE 1)

**GFA AIRWORTHINESS DIRECTIVE**

T.I. No: 109/T51

**Title:** : INSPECTION OF DART 15/17M ALUMINIUM ALLOY (DURAL) SPAR BOOMS

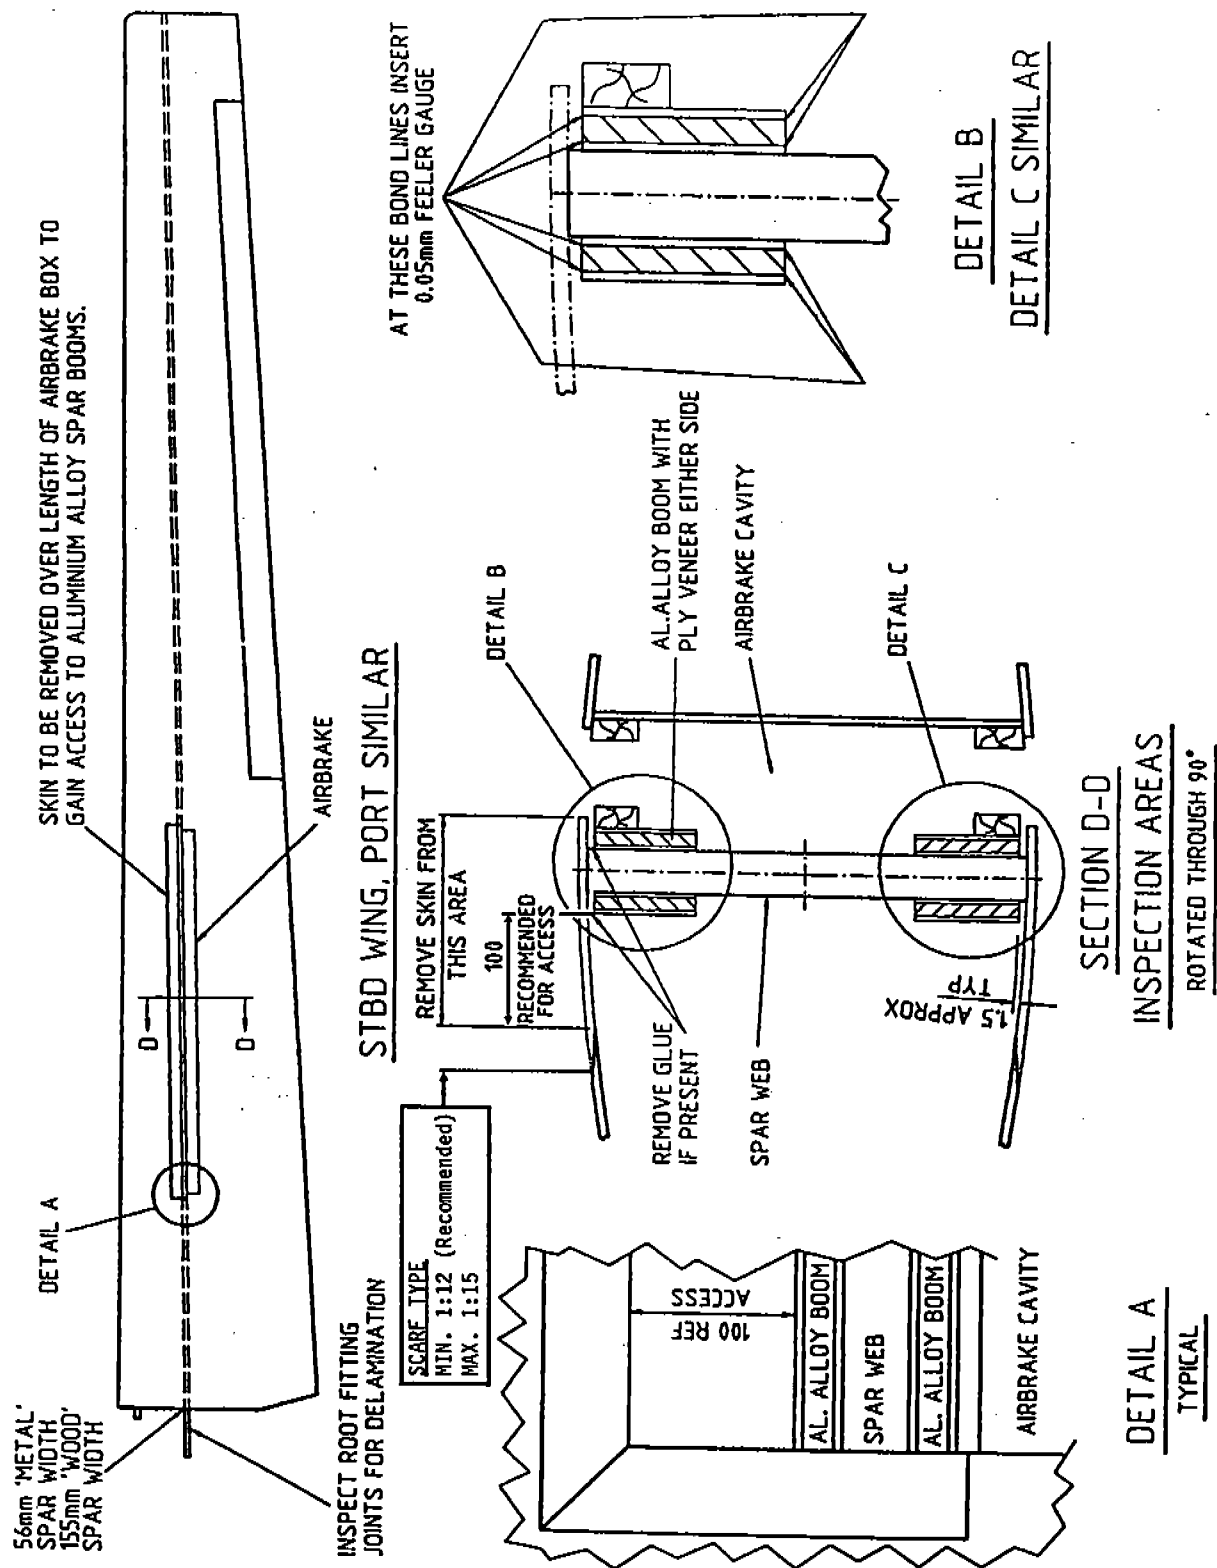
**FIGURE 1**

The skin over the spar area was removed locally along the length of the airbrake box to investigate the extent of the failures. A feeler gauge, .002" (.05mm) thick, was then run along the aluminium alloy spar boom lamination joints. This action highlighted a clean delamination over the depth of the alloy aluminium boom over a length of 150mm (6"). Further delamination was then found.

The port wing was then investigated for completeness and this too revealed delamination and corrosion at the interface of the aluminium alloy spar booms and ply veneer. Outwardly this wing showed no signs of glue failure, corrosion or water contamination.

1.
  - i) Carefully remove the ply skin from both wings, over the upper and lower spar for the length of the airbrake box. Refer to Fig. 1.
  - ii) Carefully remove paint to expose root fitting joints.
2. Ensuring aluminium alloy booms are not damaged, carefully clean away any "Redux" that may have spilt from the joints during manufacture.
3. With the aid of a feeler gauge, .002" (.05mm) check for the integrity of all exposed joints for delamination and/or exfoliation corrosion (white powdering on the metal). Ref Fig. 1 Detail B and C.
4.
  - i) If delamination or corrosion is found, the damage must be repaired before further flight. Inform SAL of the extent of the damage before proceeding with boom repairs.
