THE GLIDING FEDERATION OF AUSTRALIA

GFA AD 544
(ISSUE 1)

GFA AIRWORTHINESS DIRECTIVE

TYPE AFFECTED: Stemme S 10 and S 10-V. Serial Nos as follows -
S 10: 10-03 to 10-63;
S 10-V: 14-002 to 14-030 and 14.012M to 14-063M

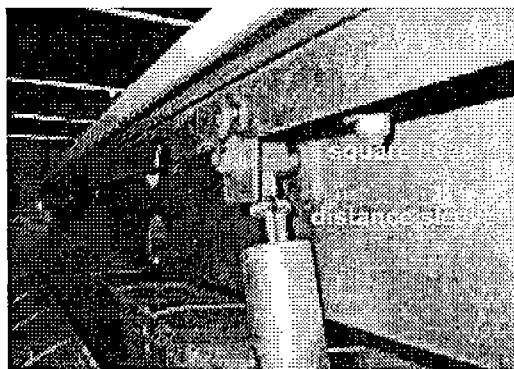
Figure 1: New version 12TI-RD

The feature that makes it possible to recognise these eye bolts (12TI-RD) based upon this Service Bulletin is a distance sleeve in the area of the screwing in the air brake lever and a square head. The "old" version has a ball head (refer to figure 1 and 2).

The eye bolts of air brakes 12TI-DB (Figure 2) and all of the fastening components belonging to it shall be exchanged with eye bolts of the 12TI-RD design (Figure 1) and their fastening components.

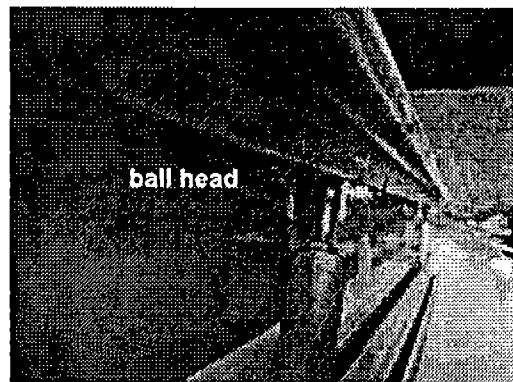
Figure 2: Old version 12TI-DB

- Action 1: At higher airspeeds near V_{NE} there may be fluttering in the upper covering straps on the air brake (air brake cover). The two mounting bolts (eye bolts) of the air brake have a significant effect upon this behaviour.
