GFA AD 550

GFA AIRWORTHINESS DIRECTIVE

SUBJECT: Valve spring retainer.

REPLACEMENT OF VALVE SPRING RETAINER ON SINGLE VALVE SPRING CONFIGURATION OF ROTAX ENGINE TYPE 912 AND 914 (SERIES)

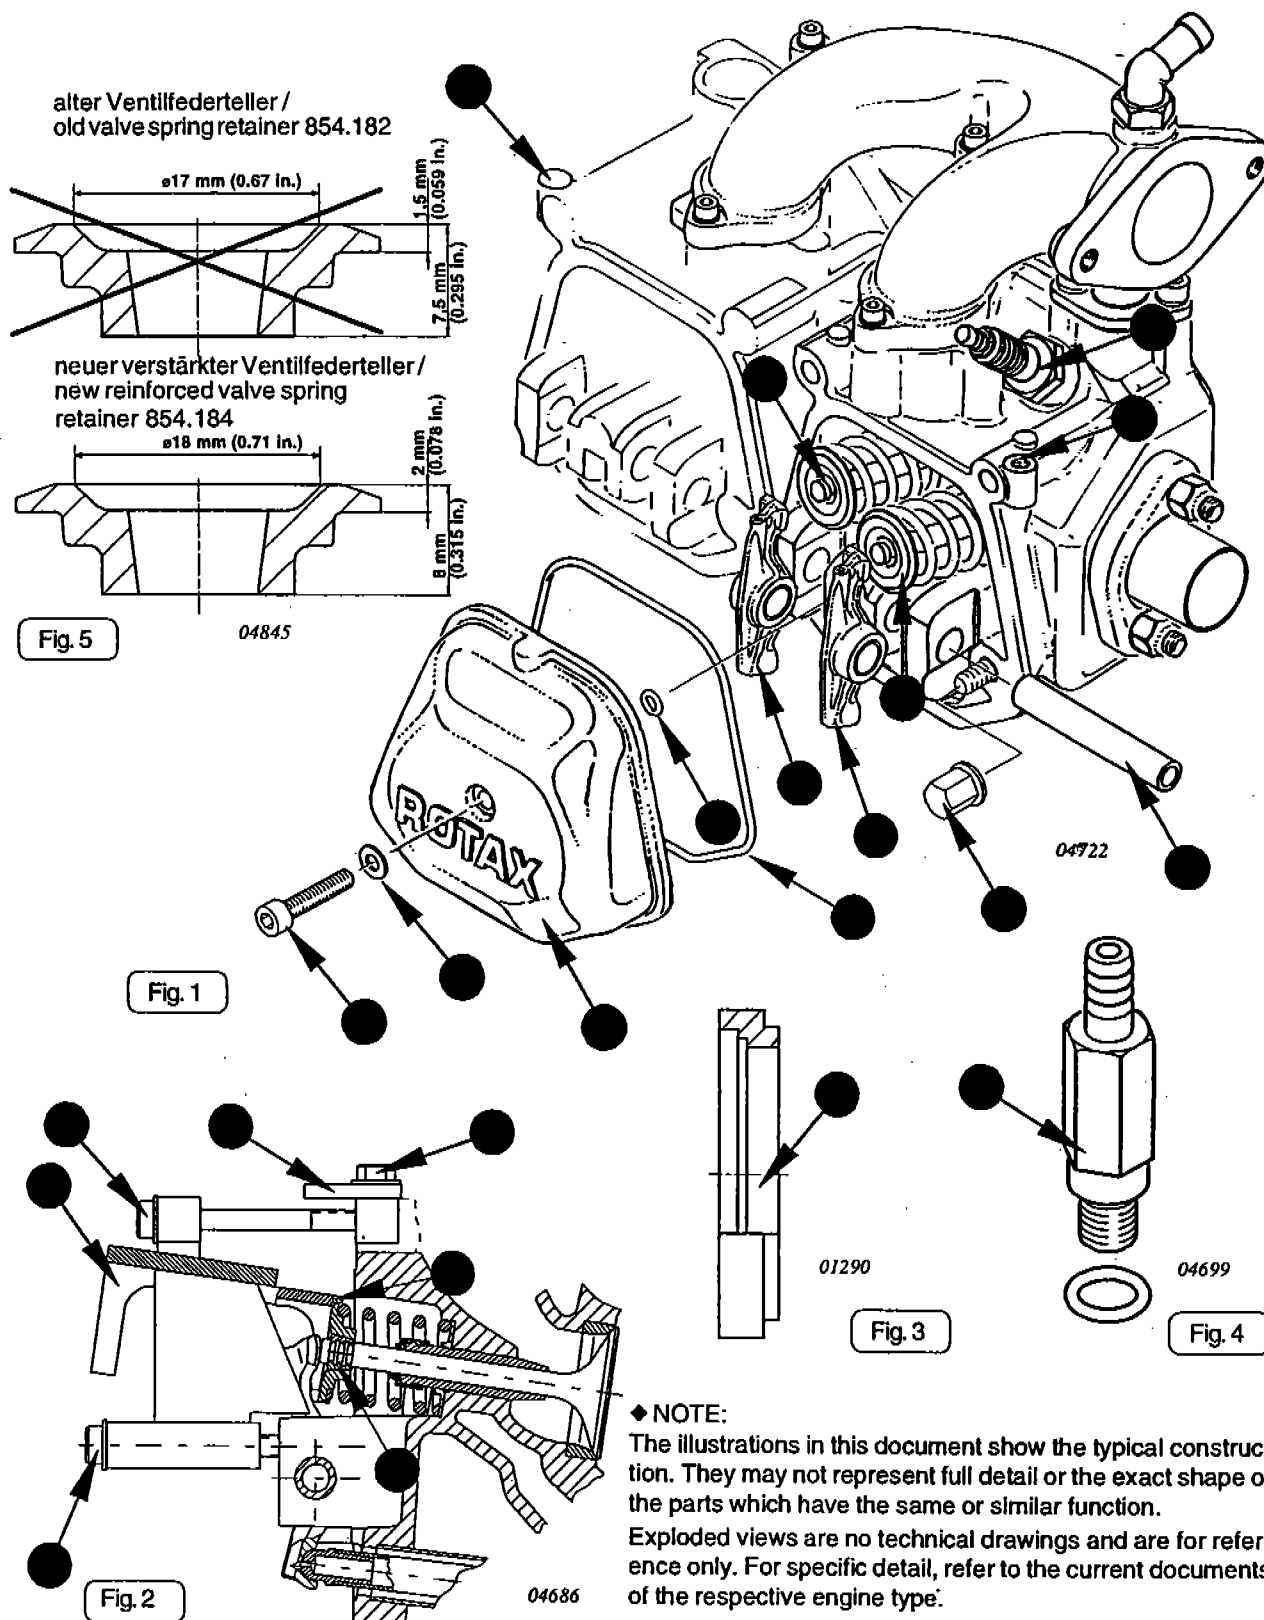
It has been discovered that during the starting procedure a delayed purging of the lubrication system could occur, which may result in cracking of the valve spring retainer. This condition can occur, if the hydraulic valve tappet has been emptied and filled with air. This is possible at first engine run or at oil change.

A detailed crack detection of the valve spring retainers is very difficult and would have to be performed repeatedly. Due to this fact all affected engines have to be equipped with reinforced valve spring retainers, which are much more resistant.

See pict. 1, 2, 3, 4 and 5.

- Place new reinforced valve spring retainer part no. 854.184 on the valve springs (see fig. 5).
- ◆ **NOTE:** To facilitate installation apply a bit of grease so that the valve spring retainer (3) will remain on the valve spring.
