GFA AD 554
(ISSUE 1)

GFA AIRWORTHINESS DIRECTIVE

TYPE AFFECTED: Diamond Aircraft;
H 36-VT
HK 36-R
HK 36-TS
HK 36-TC
HK 36-TTS
HK 36-TTC
HK 36 TTC-ECO

SUBJECT: 1. Checking or replacement of engine suspension frame (all series of engine type Rotax 912A, 912F, 912S or 914F, IF equipped with the genuine Rotax engine suspension frame as notified in Rotax Service Bulletin SB-912-028/SB-914-016).

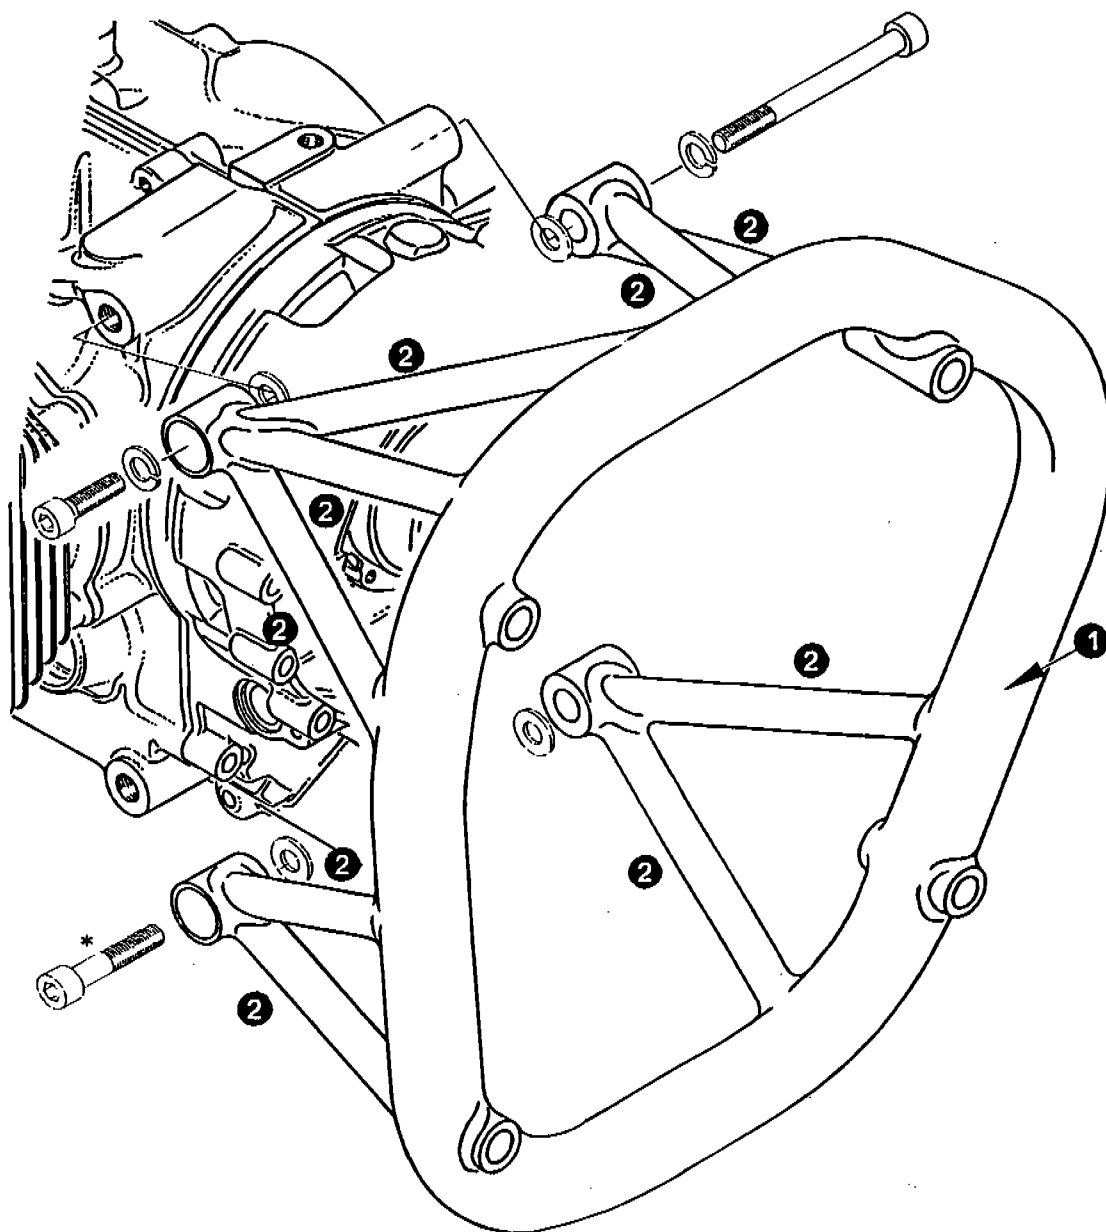
Bild / Fig. 1

Vibrations, impacts, forces etc. could cause cracks on the engine suspension frame part no. 886 567.

◆ **NOTE:** Scrutinize the welding connections of circular tubing (1) and the struts (2) of the suspension frame. See fig. 1.

- If cracks are detected replace the engine suspension frame in accordance with the relevant Maintenance Manual 914 F. That is also effective ROTAX 912 engines.

◆ **NOTE:** If absolutely necessary, and if only one of the circular tube or struts are not cracked by more than 50%, a ferry flight is permitted. At complete fracture replacement without delay will be necessary.

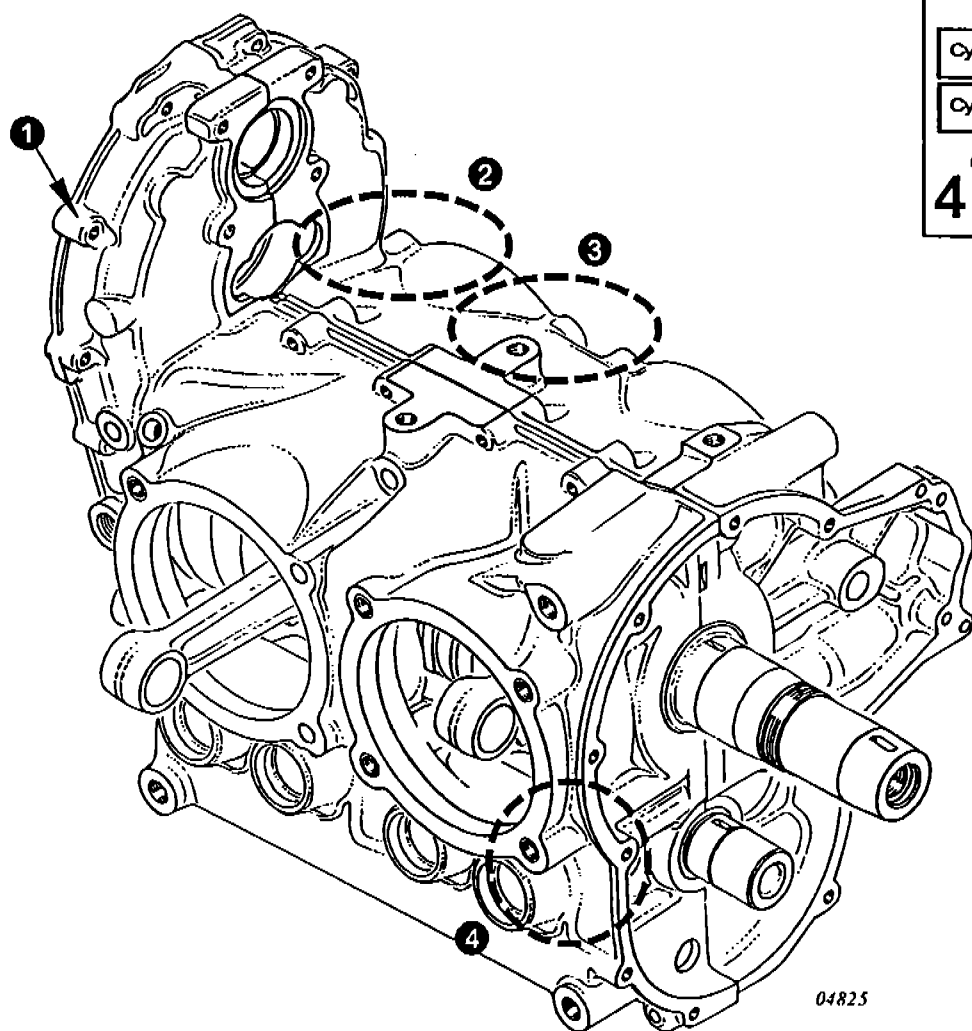
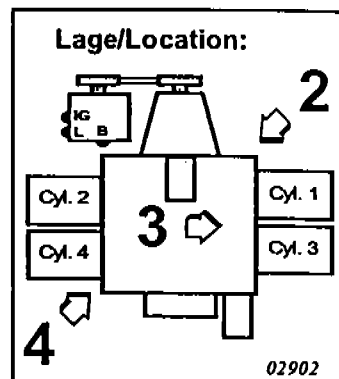
Bild / Fig. 1

Vibrations, impacts, forces, thermal strain etc. could cause cracks on the crankcase.

◆ **NOTE:** Scrutinize the crankcase for cracks especially in the area of cylinder 1 upper side (2), between cylinder 1 and 3 upper side (3) and cylinder 4 lower side (4). See fig. 1.

For those engines using cooling air baffle inspect for oil leaks in area (2) and (3). If leaks are found, then further investigation to determine the cause of the oil leak is required. If the exact origin of the leak can not be determined i.e. governor, then removal of the cooling air baffle may be required. Alternative methods of inspection may be used, i.e. bore scope, to inspect the areas without removal of the shroud.

- If cracks are detected the nearest ROTAX[®] Authorized Distributor (see also our official ROTAX-Web-Site: www.rotax-aircraft-engines.com) has to be informed and if necessary the engines has to be removed from aircraft and must be returned to a ROTAX[®] Authorized Distributor.
- Reconnect negative terminal of aircraft battery (after installation of engine).
