## THE GLIDING FEDERATION OF AUSTRALIA

**GFA AD 560**

## **GFA AIRWORTHINESS DIRECTIVE**

Cracking of tailplane mounting brackets.

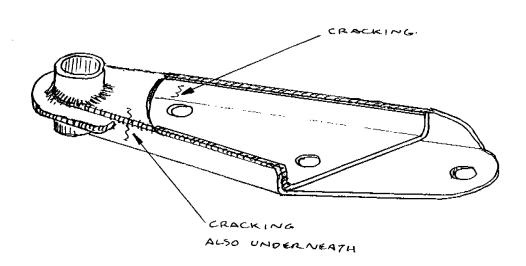
During a 30 year survey on an ES-60B, cracks were found in the tailplane mounting brackets in the fuselage. The brackets had been previously repaired by welding and were considered to be beyond further repair. New mounting brackets were manufactured and fitted.

See drawing below for locations of cracks.

- 1. Check tailplane mounting brackets for cracks, using dyepenetrant method.
- 2. If no cracks are detected, the aircraft may be returned to service.
- 3. If cracks are detected, the aircraft must not be flown and it is necessary to proceed as follows:-

- (a) If there has been no previous repair carried out, the brackets may be repaired by welding. The repair must be TIG-welded by a CASA-approved welder and a release note is required for the work in accordance with MOSP Part 3, Section 6.11.

- (b) If there is evidence of previous repair work, further repair is not permitted. New brackets must be made and fitted.
- 4. If new brackets are required, two alternatives are available;

- (a) They may be manufactured and welded up by any person holding CASA welding authority, using the original brackets as a template. The material is to be commercial mild steel plate of the same thickness as the original.
