# AIRWORTHINESS DIRECTIVE

## GFA AD 561 Issue 3

Date: 12 July 2017

## SERVICE BULLETIN NO. MSB306-36/3

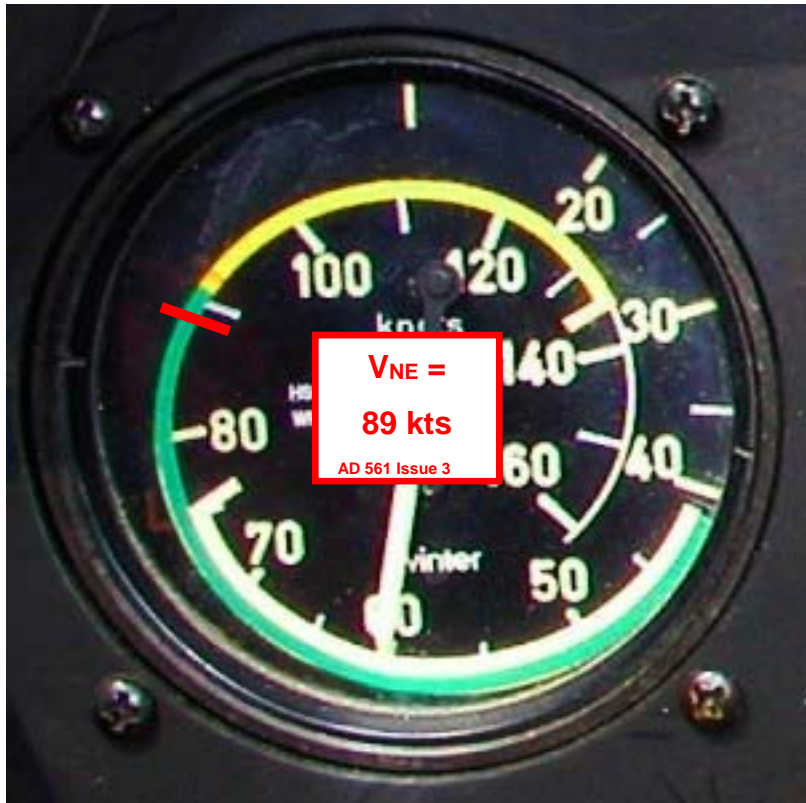
<p>The image shows a circular airspeed indicator (ASI) with a black face and white markings. The scale ranges from 0 to 140 knots, with major markings every 10 knots and minor markings every 2 knots. A red line is drawn across the scale at the 89-knot position. A red rectangular placard is attached to the center of the ASI, displaying the text "VNE = 89 kts" in red, with "AD 561 Issue 3" in smaller red text below it. The ASI is mounted on a dark panel with four screws.</p> <p><b>Figure 1: ASI Markings for Action 1</b></p> <p>2. Carry out the actions specified in Grob Service Bulletin MSB306-36/3. When this action is complete, the V<sub>NE</sub> may be restored to its original value and the red mark and decal on the airspeed indicator can be removed.</p>

<p>3. Service Bulletin MSB306-36/3. Increase of Mass Balance</p>
<b>Required Action(s)</b>	<p>1. Apply a red mark on the airspeed indicator at 89 knots using instrument decal, marking tape or similar. Apply a red placard to the airspeed indicator as shown in Figure 1.</p> <p>Enter a minor defect into the maintenance release stating "AD561 Issue 3 Action 2 not carried out – VNE restricted to 89 kts".</p> <p>At each Annual Inspection the minor defect is to be entered into the new maintenance release. The decal and airspeed indicator mark should be inspected for adhesion and clarity.</p> <p>At each Annual Inspection the Annual Inspection Report is to have a statement "AD561 Issue 3 Action 2 not carried out. Aircraft operating with reduced VNE."</p>
