## THE GLIDING FEDERATION OF AUSTRALIA

**GFA AD 563**  
(ISSUE 1)

**TYPE AFFECTED:** Diamond Aircraft :-  
H-36 Dimona, serial numbers 36.220 and up (all Dimona Mk II);  
H-36 VT, all serial numbers;  
HK-36 Super Dimona, all serial numbers;  
HK-36 R Super Dimona, all serial numbers;  
HK-36 TS, all serial numbers;  
HK-36 TC, all serial numbers;  
HK-36 TTS, all serial numbers;  
HK-36 TTC, all serial numbers;  
HK-36 TTC-ECO, all serial numbers.

**SUBJECT:** Canopy locking mechanism.

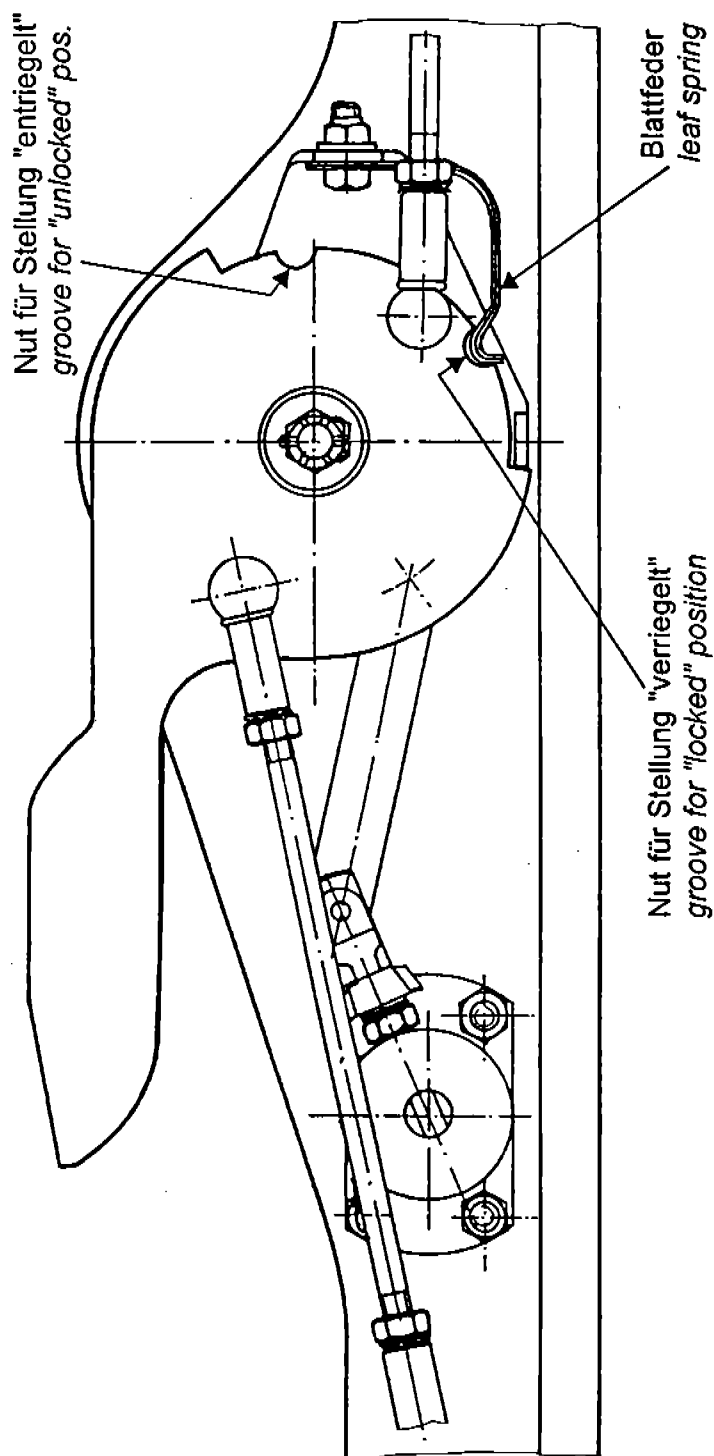
- (c) Einrastmechanismus links und rechts überprüfen (siehe Abb. 1).
    - Blattfeder und Nut auf Verschleiß kontrollieren.
    - Durch visuelle Überprüfung sicherstellen, daß die Feder in Stellung "verriegelt" (roter Hebel ganz vorne) vollständig in die Nut einrastet. Das Einrasten muß bei geöffneter Haube spürbar sein.

1. Inspection of canopy locking mechanism on both sides.
  - (a) Remove LH and RH cover (3 Phillips screws each).
  - (b) Check LH and RH locking mechanism for corrosion and insufficient lubrication. Also refer to Service Information No. SI36-004.
  - (c) Inspect LH and RH snap-in mechanism (see Fig. 1).
    - Check leaf spring and groove for wear.
    - Ensure by visual inspection that the spring engages in the groove completely when the red lever is in the "locked" (full forward) position. Snap-in must be noticeable when the canopy is open.
  - (d) Check lock wire for canopy jettison mechanism for damage.
  - (e) Ensure that the 4 locking bolts are not lubricated.
  - (f) Ensure that all 4 locking bolts protrude from the canopy frame contour by 2.5 to 3.5 mm (0.10 to 0.14 in) when the levers catch in the "unlocked" position (see Fig. 2).

Abbildung 1: Korrektes Einrasten der Blattfeder in der Nut  
Figure 1: Proper Engagement of Leaf Spring in Groove

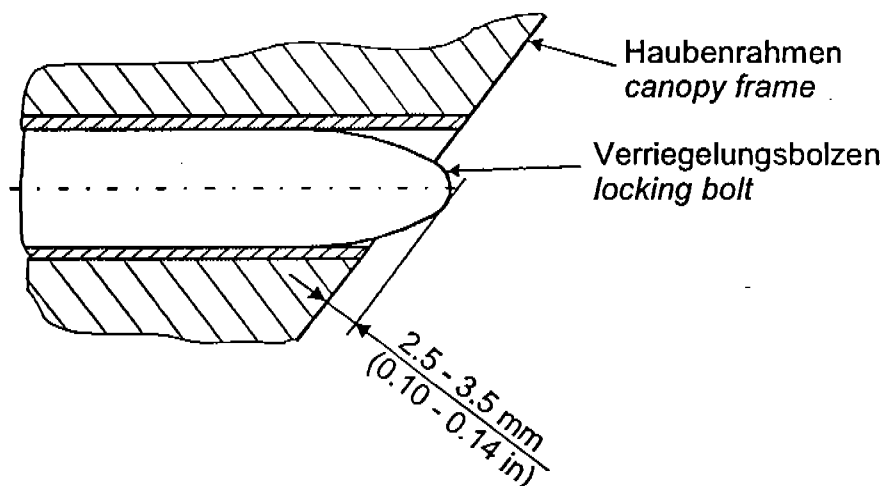
- (f) Sicherstellen, daß alle 4 Verriegelungsbolzen um 2,5 bis 3,5 mm aus der Haubenrahmenkontur ragen, wenn die Hebel in Stellung "entriegelt" einrasten (siehe Abb. 2).

Figure 2: Adjustment of Locking Bolts

If necessary, adjust position of the bolts (at those connection rods which are connected to the red locking levers). The threads on both ends of each connection rod must be screwed into the mating parts at least 5 mm (0.2 in) deep. If this is not possible, then longer connection rods must be installed (front: part no. 123661, rear: part no. 128481).

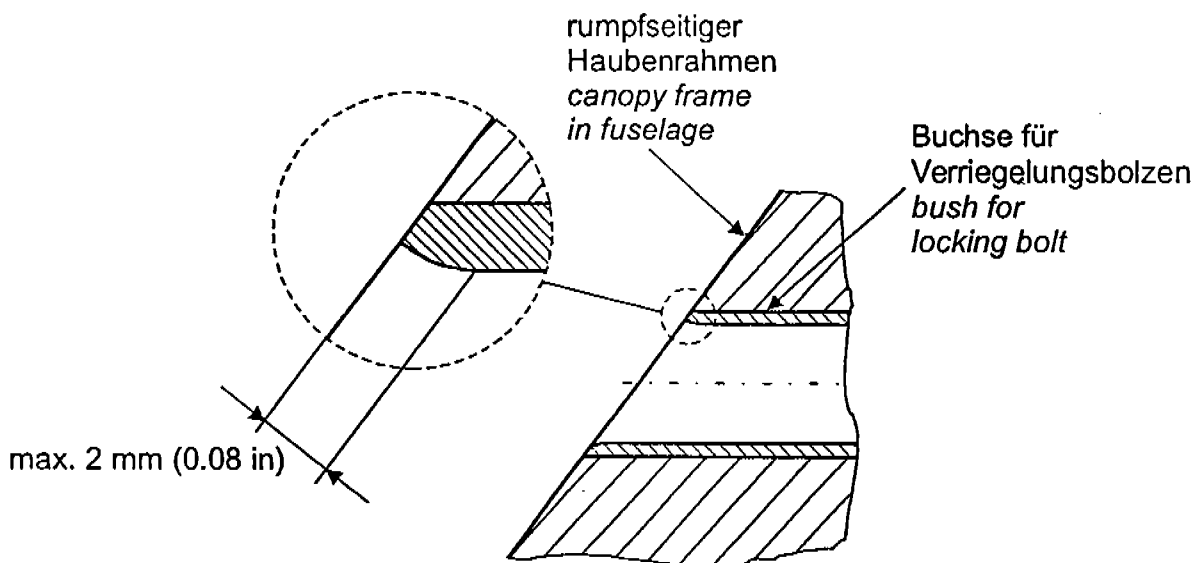
- (g) On the canopy frame in the fuselage: check bushes for all 4 locking bolts for excessive wear on the edge (max. 2 mm / 0.08 in, see Fig. 3). If necessary, replace bushes.
  - (h) Ensure that the LH and RH locking levers can be moved fully forward with the canopy closed (i.e., as far forward as with the canopy open). Verify proper engagement of the spring by visual inspection (see Fig. 1).
  - (i) Install cover.
2. The following placard (color: red) must be attached next to the ignition switch:

Figure 3: Maximum Wear of the Bushes in the Canopy Frame in the Fuselage
