# GFA AD 566

**TYPE AFFECTED:** PW-5 Smyk, all serial numbers.

**SUBJECT:** Inspection of bonded joint and inspection procedure if de-bonding is found.

### **No. BO-17-02-16**

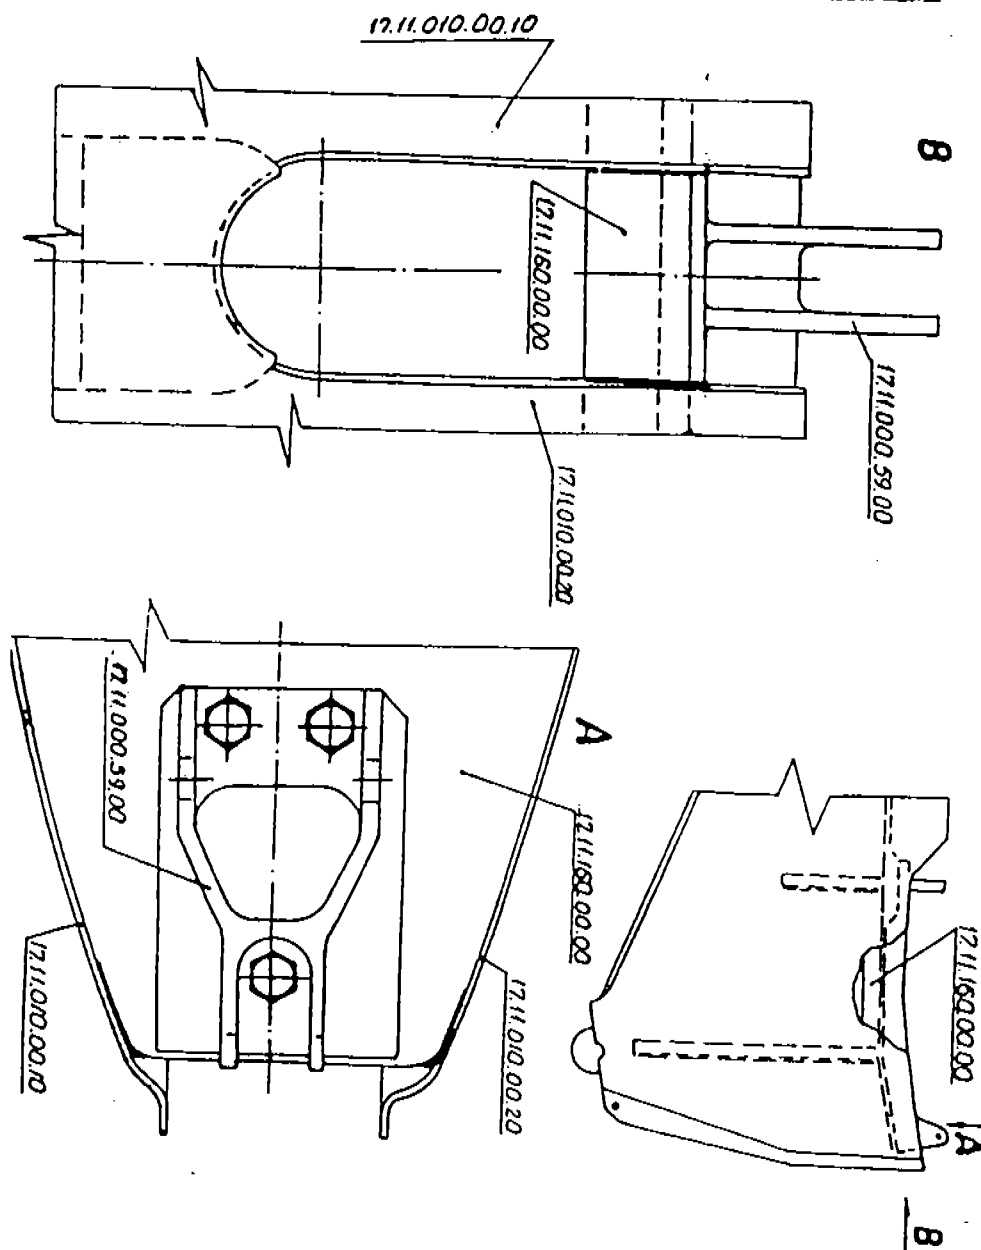
Sketch No. 1

In relation to the cases of adhesive-bonded joint cracks between the wall P/N 17.11.160.00.00 and the fuselage shell P/N 17.11.010.00.10 or 17.11.010.00.20 after the inspection of sailplanes, series 17.06... and 17.07..., in accordance with the bulletin BO-17-01-15, it is recommended to perform the inspection of the area shown in the enclosed sketch No. 1 in all operated sailplanes.

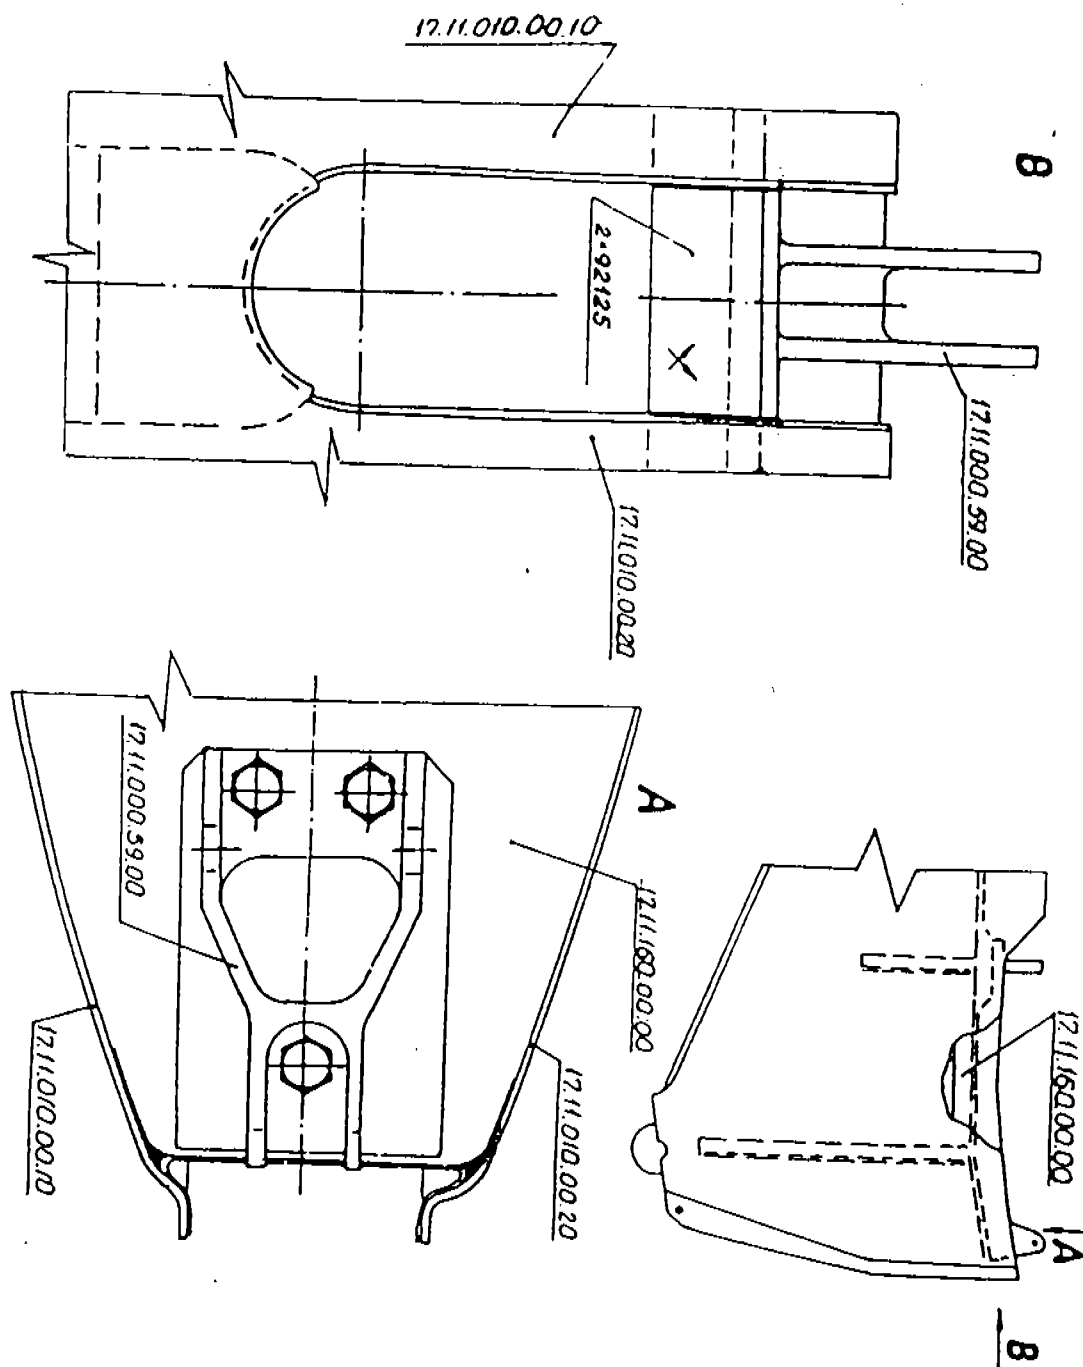
Sketch No. 2

This bulletin has been issued to inform that in case the crack is detected, the damaged adhesive-bonding joint is subject to the following repair procedure:

1. Remove the damaged adhesive-bonding joint.
2. Degrease and roughen both surfaces.
3. Prior to bonding the reinforcement, prepare the rear surface of wall (17.11.160.00.00.) and the adjacent fuselage skins (17.11.010.00.10/20) by degreasing and roughening them.

4. Repair the removed adhesive-bonded joint by injecting new bonding composition (epoxy resin EP-53 + hardener Z-1 + filler: 4 parts colloidal silica (Aerosil®, Cab-o-sil®, HDK®N20) by weight per 100 parts resin).
5. Over whole length and width of rear surface of wall (17.11.160.00.00), adhesive bond two layers of Interlass 92125 cloth, impregnated with laminating composition of EP-53 + Z1, which should overlap onto fuselage skins in accordance with sketch No. 2.
6. Perform after-baking of the repaired structure in the following cycle: 24 hrs at temp. 19÷25 C + 15 hrs at temp. 50÷60 C.
