## GFA AIRWORTHINESS DIRECTIVE

- SUBJECT:** Checking of the curled or pressed ends of light metal control rods for visible cracks.
- BACKGROUND:** Cracks have been discovered in the ends of light metal control rods with curled or pressed ends in the area of the beading. See attached Service Bulletin.

<b>STEMME</b> F & D LBA.NSD.005	<b>Service Bulletin</b>		Document Number: <b>A31-10-059</b>
	<b>Inspection of control rods for cracks</b>		Am.-Index: 01.a
			Page: 4 of 5

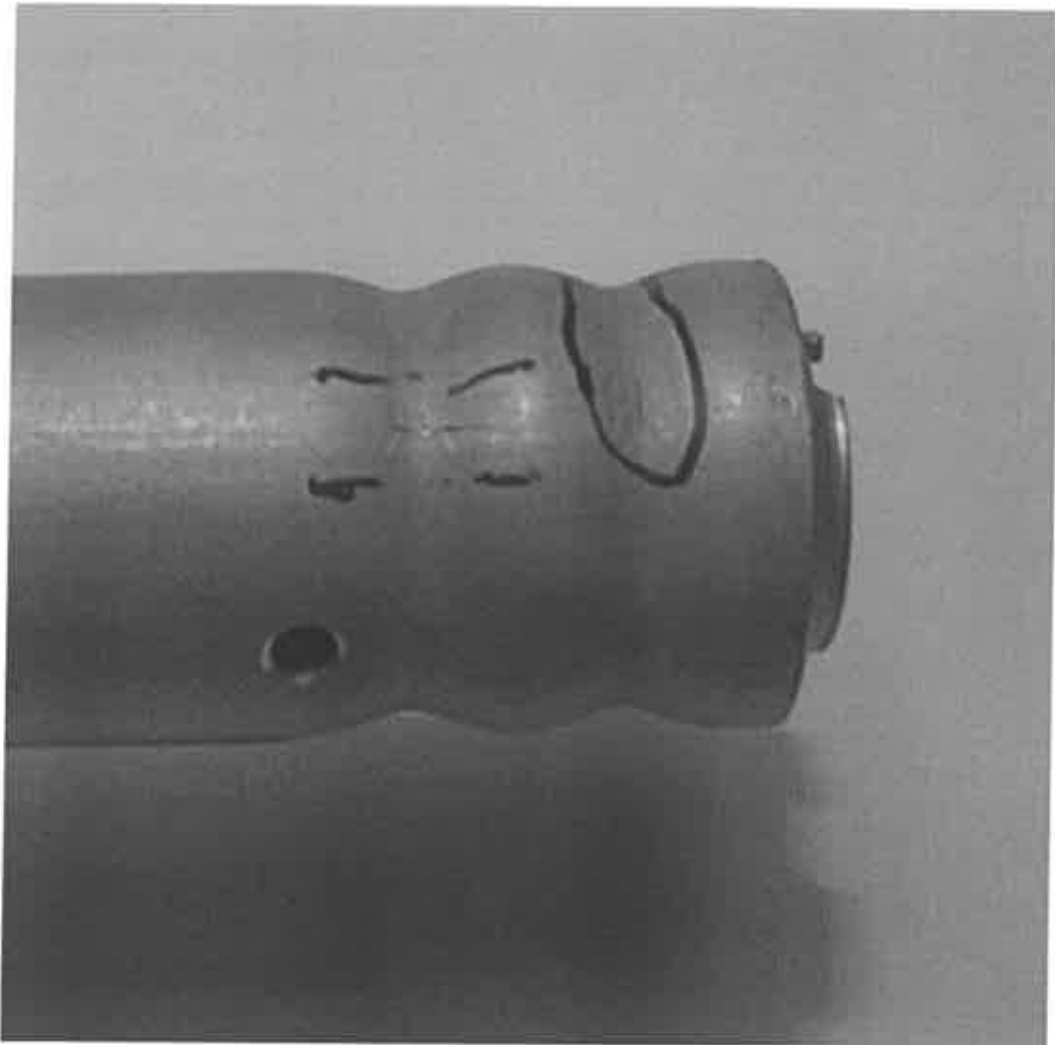
The following types of individual cracks with a depth of between 0.08 in. and 0.39 in (2mm and 10mm) have been discovered on the light metal control rods with curled or pressed end-pieces in the area of the beading:

- Across the control rod: usually on the sides, but also in the dip of the compression. In the case of compressions, cracks usually in irregular / extremely cruciform compressions.
- Alongside the control rod: in the compression area, usually on the peak of the compression.
- *Longitudinal grooves on the surface, which look like a crack. They occur during the drawing process of the manufacture of the half-finished product and do not play a significant role in safety.*

The possibility cannot be safely eliminated that any existing deep cracks can increase in size and depth during the operation of the aircraft (e.g. as a result of high levels of stress and / or corrosion). It is for this reason that affected light metal control rods must be controlled and, if a defect is found, they are to be replaced.

Bild 1 / picture 1:  
 Beispiel eines signifikanten Anrisses in der Einrollung / example for a significant crack in the control rod

As part of this SB, one single, thorough inspection of the curled or pressed end-pieces of the control rods is to be carried out in accordance with the specified inspection report D23-10S-001, after which normal controls will be carried out in accordance with the specifications in the maintenance manual.
