GFA AIRWORTHINESS DIRECTIVE

SUBJECT: Rudder gimbal drive, rear actuator arm.

**Airworthiness
Directive
2003-005**

Flight Controls - Rudder gimbal drive - rear actuator arm

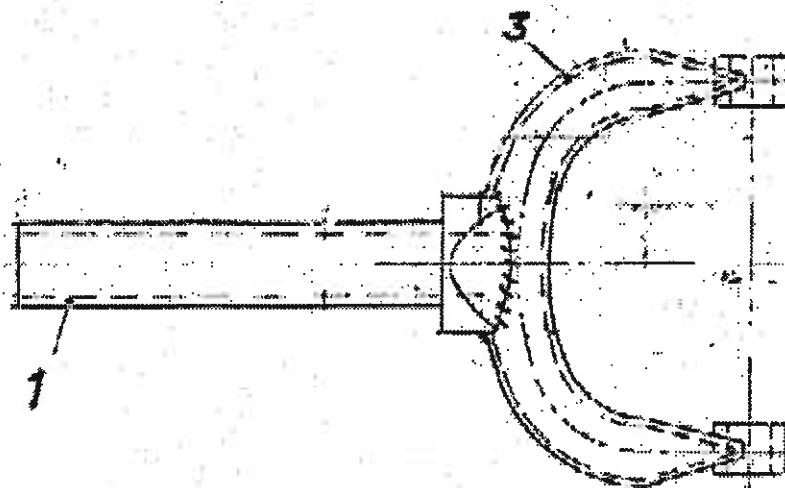
203-15-10-2

Ruderlenker

1 off rudder actuator arm made according to drawing 203-45-10-2
1 off M4 stop nut
3 off Split pins, 1.5 x 16 mm

Only genuine parts made in accordance with drawing No. 203-45-10-2 must be used.
