GFA AIRWORTHINESS DIRECTIVE

TYPE AFFECTED: Schempp-Hirth Discus 2a and Discus 2b, serial numbers as follows; 13 to 22; 24, 27, 28, 30 to 48, 50, 51, 53 to 55, 57 to 63, 65, 67, 68, 71 to 79, 81, 82.

SUBJECT: Elevator and elevator pushrod.

SHEMPP-HIRTH Flugzeugbau GmbH. Kirchheim/Teck	Technical Note No. 360-19	Page No. 01 No. of pages 02								
<u>SUBJECT:</u>	Horizontal tailplane and elevator pushrod									
<u>AFFECTED:</u>	Sailplane Discus-2a and Discus-2b (TC-No. 360) Serial Nos: 13 - 22, 24, 27, 28, 30 - 48, 50, 51, 53 - 55, 57 - 63, 65, 67, 68, 71 - 79, 81 and 82 <u>Important remark:</u> <u>Not</u> affected are sailplanes which comply with Technical Note No. 360-16 !									
<u>URGENCY:</u>	At the occasion of the next annual inspection, but not later than April 30, 2003.									
<u>REASON:</u>	To improve the flutter stability a mass balance on the elevators in connection with a lighter elevator pushrod in the vertical fin have to be installed.									
<u>ACTIONS:</u>	<div>1. <u>Elevators</u> A mass balance must be added to the elevators according the working instructions that the hinge moments are within the tolerances of the datas on page 2.2.1, issue December 2002, o

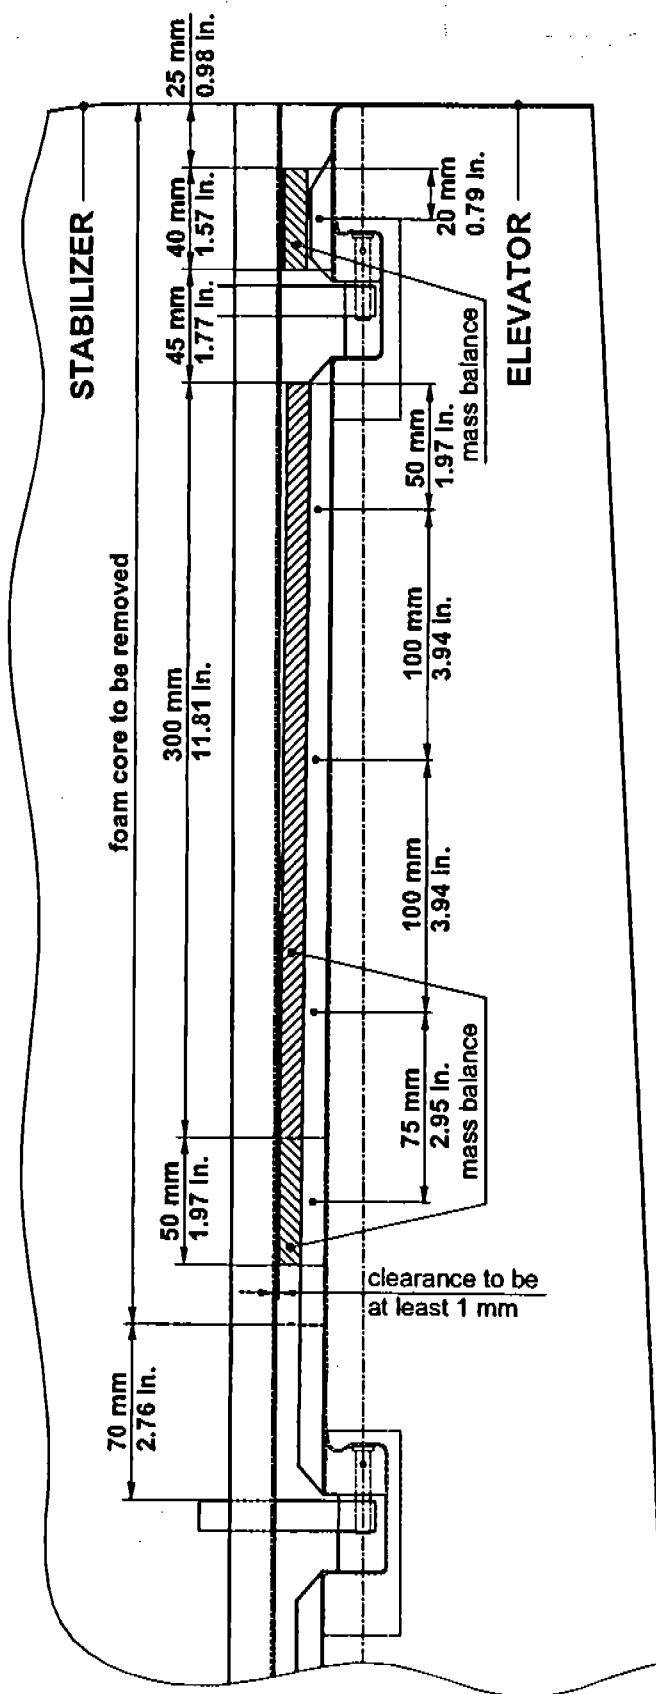
WORKING INSTRUCTIONS FOR INSTALLING ELEVATOR MASS BALANCE

1. Remove sealing tape prior dismounting the elevator halves.
2. Stabilizer
 - a) Remove glass cloth and foam core from shroud up to the web
- see also page 02 and 03.

- b) Reinforce shroud and web by applying additional carbon/glass cloth layers – see page 03.
3. Mass balance
 - a) Fit mass balance weight to elevator halves; make sure that there is a clearance of at least 1 mm between lead and web – see page 03.
If necessary, shorten elevator joining flange ahead of the hinge or grind off mass balance at the leading edge..

- b) Bond mass balance weight in place and install roll pins.
 - c) Check elevator for free travel and determine residual moment (revised values shown in the Maintenance Manual).
If required, fit and install further mass balance (inwards) as described above – for gaining more space follow step 2.) if necessary.

- d) Check once more elevator for sufficient travel – if necessary, grind off balancing lead.
 - e) Determine residual moment and mass of elevator halves.

4. Reinstall elevator halves.
5. Check elevator for free travel and proper deflections within the permitted range.
6. Install again the sealing tapes.

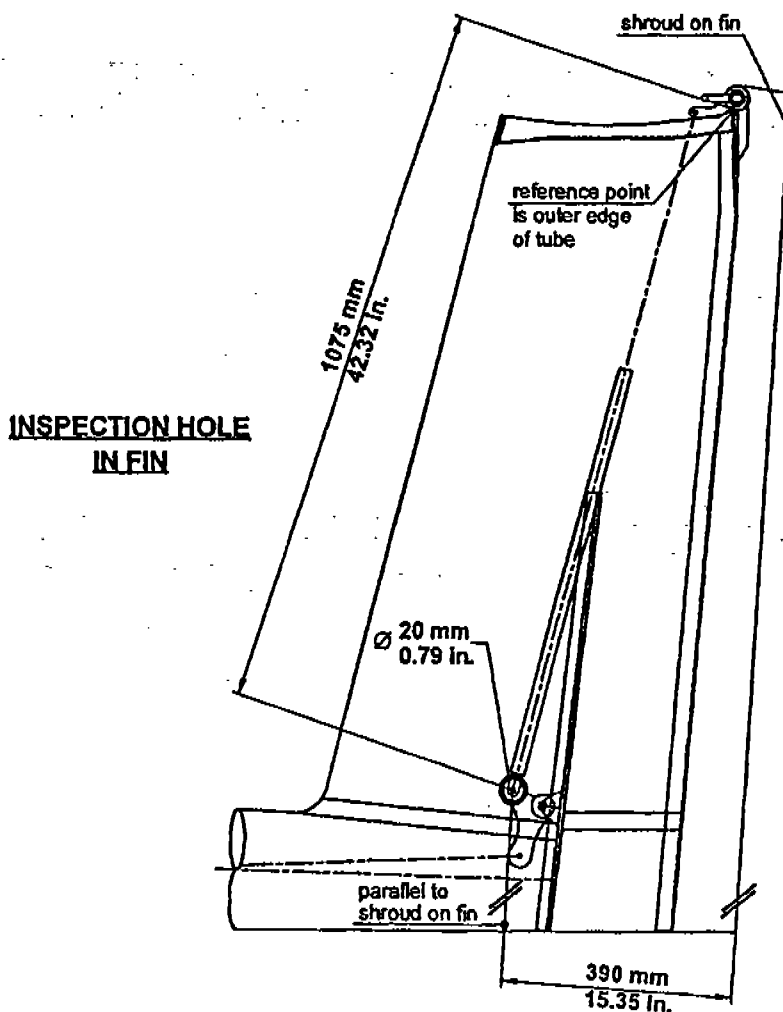
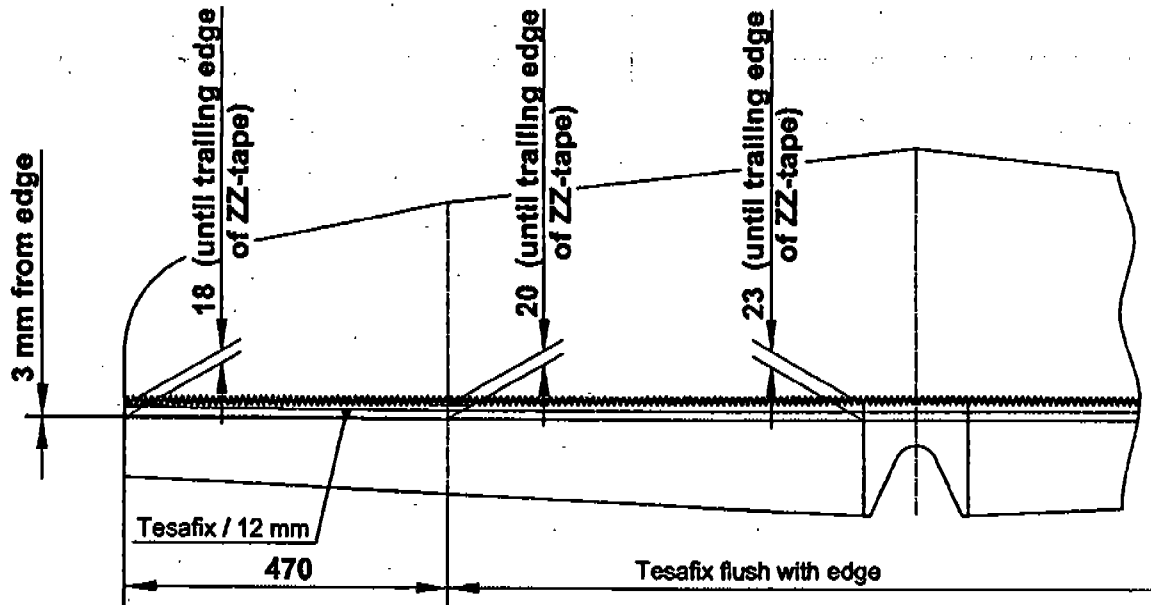
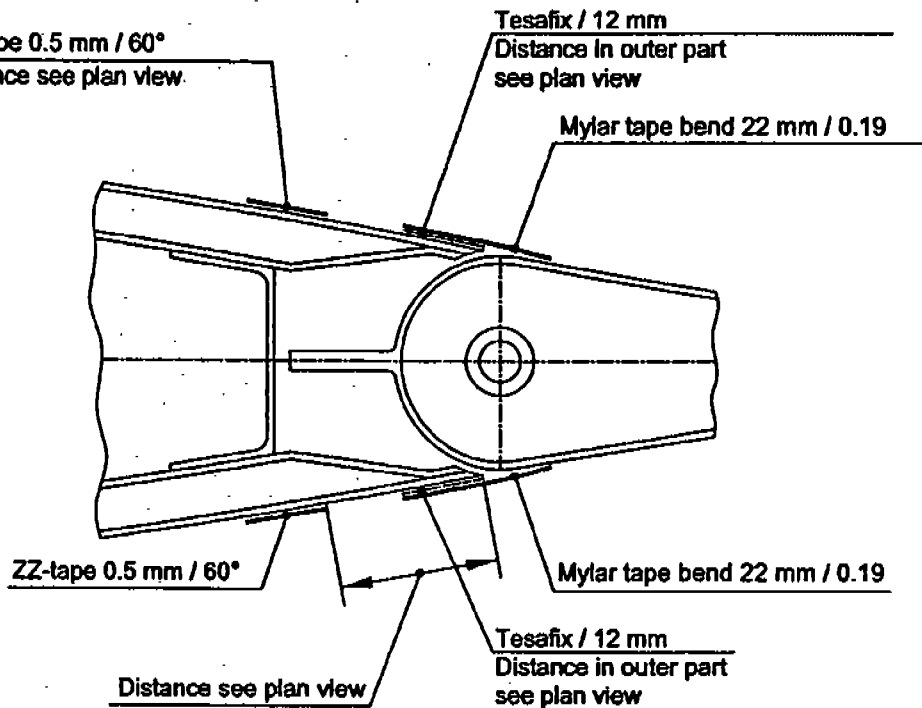
ZZ - tape position and sealing

ZZ-tape 0.5 mm / 60°
Distance see plan view.
