GFA AD 587

GFA AIRWORTHINESS DIRECTIVE

TYPE AFFECTED: Diamond Aircraft HK-36 R and T series, all serial numbers.

SUBJECT: Checking of the crankcase of Rotax 912 and 914 engines.

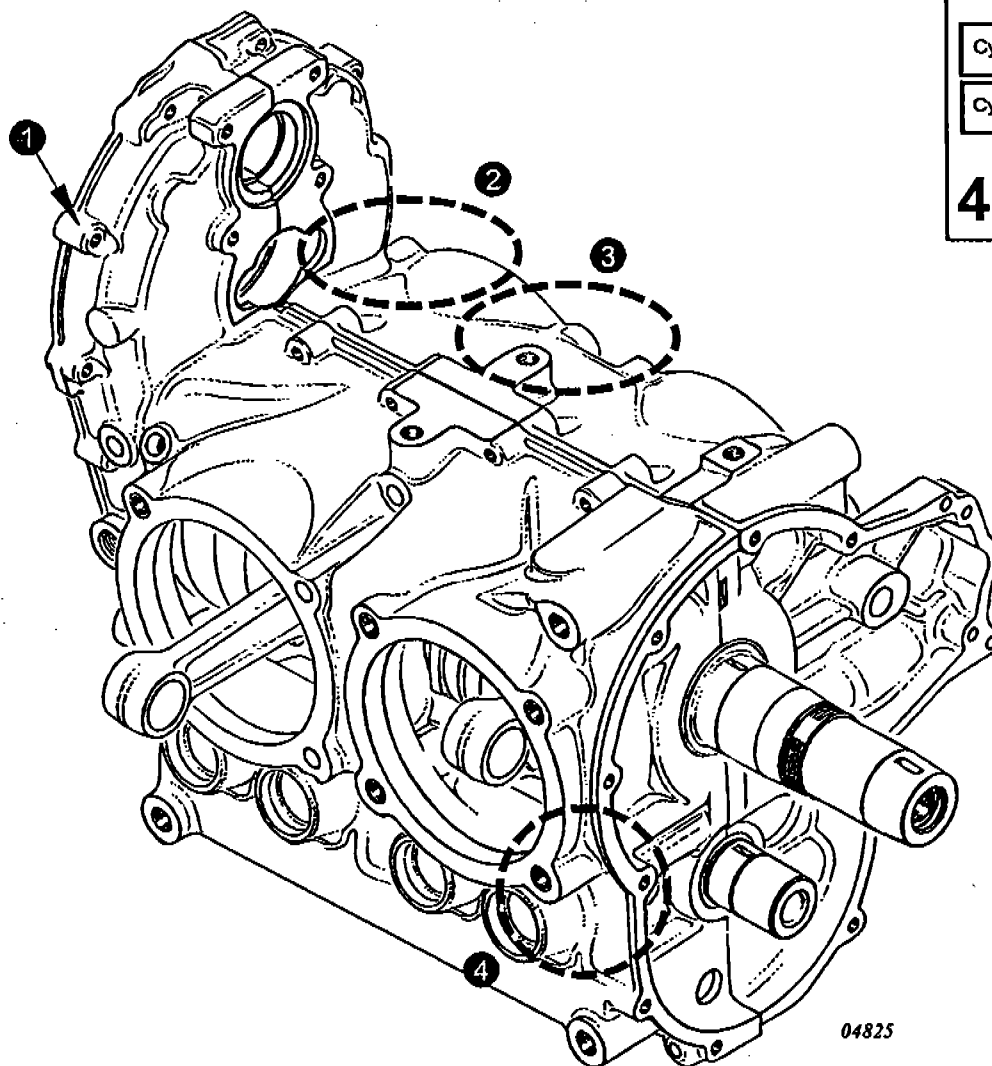
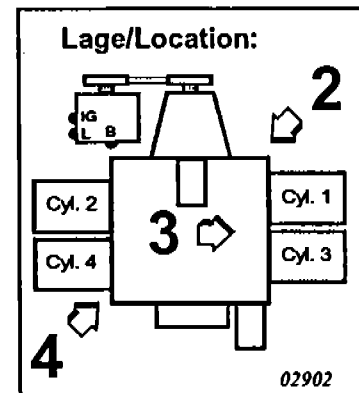
Bild / Fig. 1

◆ **NOTE:** Scrutinize the crankcase for cracks especially in the area of cylinder 1 upper side (2), between cylinder 1 and 3 upper side (3) and cylinder 4 lower side (4). See fig. 1.

For those engines using the ROTAX_® cooling air baffle. Visually inspect for oil leaks in area (2) and (3). If leaks are found, then further investigation to determine the cause of the oil leak is required. If the exact origin of the leak can not be determined i.e. governor, then removal of the cooling air baffle may be required.

- Visually inspect the crankcase (1) and engine suspension for cracks in accordance with the relevant Maintenance Manual.

- If cracks are detected the nearest ROTAX_® Authorized Distributor (see also our official ROTAX-Web-Site: www.rotax-aircraft-engines.com) has to be informed and if necessary the engines has to be removed from aircraft and must be returned to a ROTAX_® Authorized Distributor.
