GFA AD 589

GFA AIRWORTHINESS DIRECTIVE

Pilatus B4-PC11, B4-PC11A and B4-PC11AF, all serial numbers.

Inspection/replacement of control-column support on frame 2.

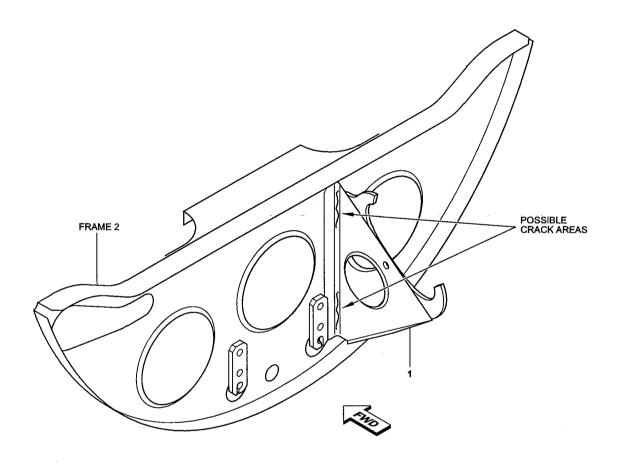
Support Frame 2 - Inspection Figure 1

During inspections cracks have been found in the control-column support on frame 2. Failure of the support could lead to loss of control of the aircraft

- (1) Use a source of bright light and X10 magnifier and examine support (1) for cracks. Do this specially in the areas of the upper and lower bend angles where the support (1) is attached to Frame 2.
- (2) Cracks are not permitted in the support (1). Replace the support (1) if you find cracks.
- (3) Do the inspection again at each annual servicing.

1. In accordance with the Service Bulletin referred to above, inspect the control-column support for cracks, especially in the areas of the upper and lower bend angles where the support is attached to frame 2. NO CRACKS ARE PERMITTED. If no cracks are found, the aircraft may be returned to service immediately. If cracks are found the aircraft must be grounded until the support is replaced with a new part. The aircraft may then be returned to service
