GFA AD 591

GFA AIRWORTHINESS DIRECTIVE

Replacement of the oil dipstick.

INTRODUCTION OF A NEW OIL DIPSTICK FOR ROTAX, ENGINE TYPE 912 AND 914 (SERIES)

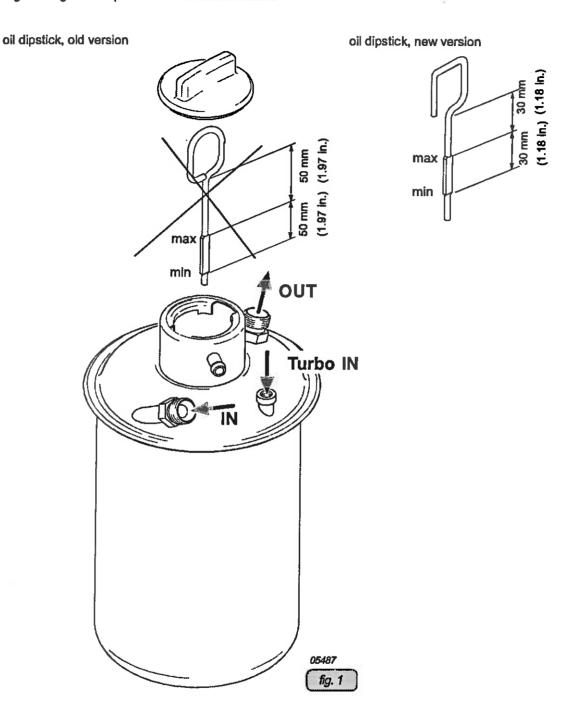
It has been discovered, in some cases, that the new characteristics of some modern oils can result in a slower return of oil from the crankcase to the tank under certain conditions. This could possibly cause the oil tank level to fall to a level below the minimum. In order to help prevent this problem it is necessary to raise the minimum oil level in the tank. This is achieved by using a new dipstick with new level marks.

- Remove the oil dipstick part no. 956150 and replace by new oil dipstick part no. 956151.
- inspect the oil level to be performed SI-27-1997 "Oil level check", current issue.
- Add oil if necessary.
- ◆ NOTE: By changing the oil dipstick, the minimum oil level is raised by approx. 40 mm (1.57 in.) and the height between the "min." and "max." level is reduced to 30 mm (1.18 in.) (approx.0,45 litre).
- Restore aircraft to original operating configuration.
- Connect negative terminal of aircraft battery.
