GFA AIRWORTHINESS DIRECTIVE

SUBJECT: Inspection of Exhaust Muffler Part No. 979402 fitted to Rotax 914 series engines.

**TECHNISCHE INFORMATION NR.
SERVICE INFORMATION NO.
SI36-026
SI22-008
SI40V1-009**

INSPECTION OF THE EXHAUST MUFFLER PART NO. 979402 FOR ROTAX® ENGINE TYPE 914 SERIES ASB-914-028R1

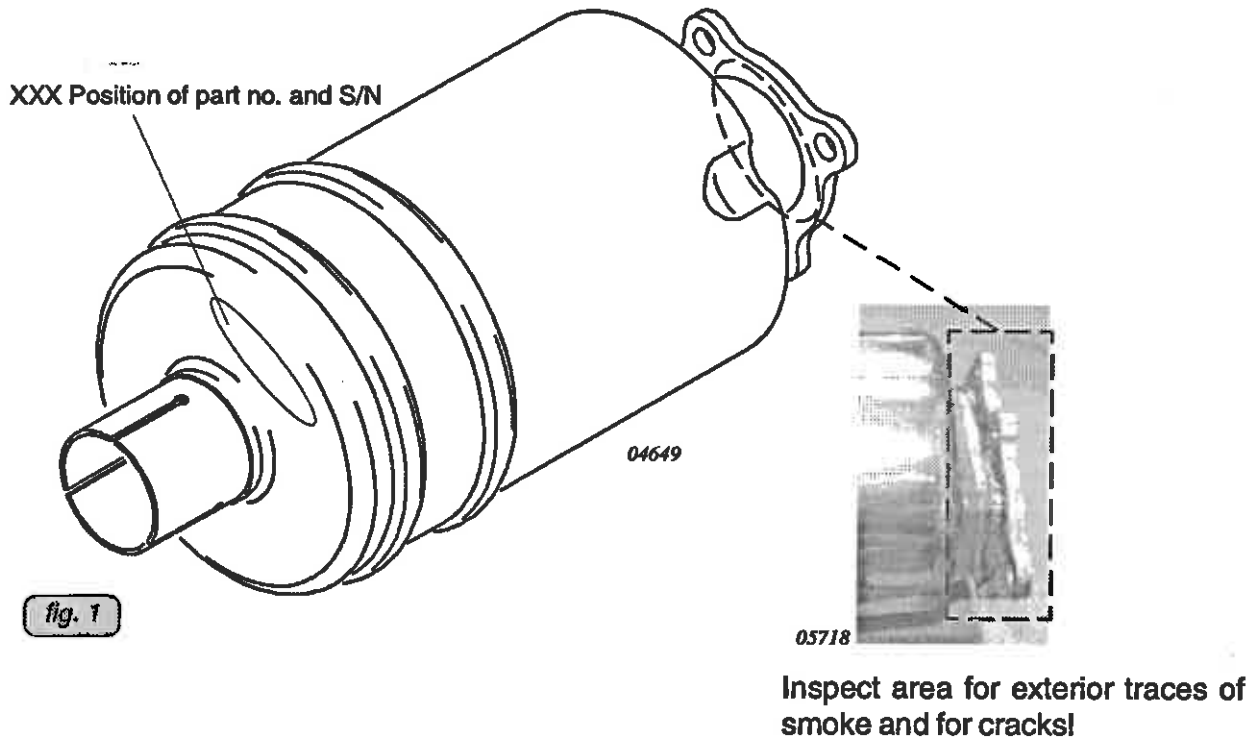
see fig. 1

Cracks occurred on genuine ROTAX® exhaust muffler part no. 979402

◆ **NOTE:** Particular inspection in the area (exhaust flange) for exterior traces of smoke or existing cracks in the fillet (weld inlying) (as shown in fig. 1).

- If exterior traces of smoke or cracks are detected, do not operate the aircraft and immediately contact the nearest ROTAX_® Authorized Distributor or their Service Centers for further action. (see also our official ROTAX-Web-Site: www.rotax-aircraft-engines.com).
