# **GFA AD 597**

## **GFA AIRWORTHINESS DIRECTIVE**

Modification of the Canopy Jettison System

## SERVICE BULLETIN NO. MSB306-37 MSB320-08

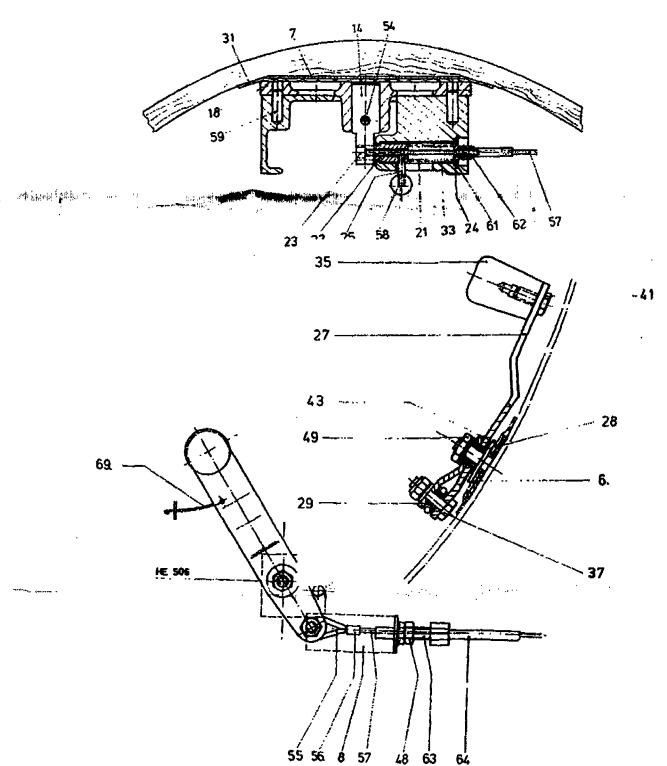
A research report issued by the college of Aachen has shown, that the installation of a canopy joint, installed in the rear, represents the ideal solution for a canopy jettsion system. As such a canopy joint is already installed in the affected gliders, the canopy jettison system can be improved.

- 1.8.2 The canopy jettison operating lever including operating cable must be removed as follows (refer to illustration on page 4):
  - remove the RH cockpit covering
  - remove bolt (37)
  - cut-off cable (57) and remove adjusting screw (48) and remove completely operating cable (64)
  - remove safety wire (69)
  - remove nut (49) and operating lever (27)
  - cut-off cable (57) from canopy joint
  - remove cable rest with socket (62) and nipple (23)
  - install RH cockpit covering
  - remove placard "Canopy Jettision" from canopy jettison operating lever

NOTE: The canopy can be removed for maintenance purposes by operating the red ball knob (58)
