GFA AIRWORTHINESS DIRECTIVE

TYPE AFFECTED: DISCUS VENTUS

SUBJECT: Jamming of Elevator caused by loose mass balance weights.

SUBJECT: Elevator, fixing of mass balance weights

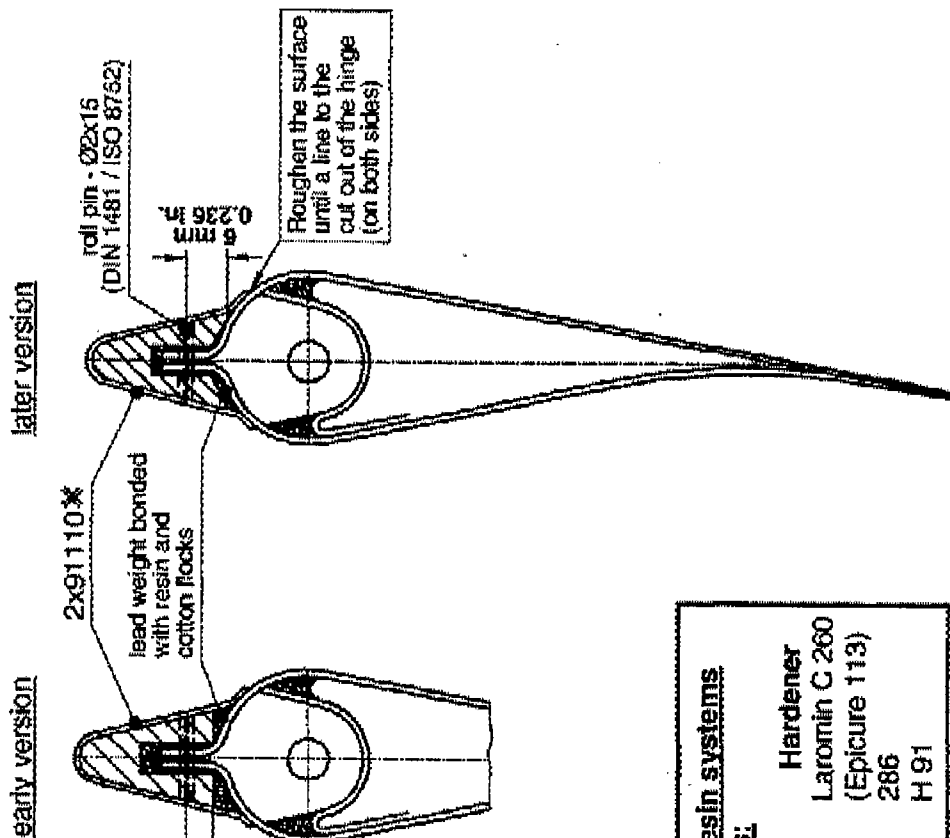
Outer lead weight

BACKGROUND: During a Daily Inspection a roughness of the elevator control was noticed. This was traced to the tailplane and on removal of one of the elevators two loose pieces of lead were found. The outermost mass balance weight had separated from the leading edge of the elevator and was broken into two pieces.

3. If the lead pieces are solidly fixed with resin and roll pins:
 - a) At the inboard lead pieces roughen the visible gaps and fill the gaps flat with resin thickened with cotton flocks.
 - b) At the outboard lead piece roughen the gap between lead and a line on the elevator, see sketch on page 2 and roughen the surface of the lead.
 - c) Fill the gaps flat with resin with cotton flocks and apply two layers of glasfibre on the lead, see sketch on page 2.

4. If a lead piece is not solidly fixed anymore (loose):
 - a) Remove the roll pins.
 - b) Roughen all bonding surfaces of the lead and elevator.
 - c) Attach the lead piece with resin with cotton flocks and take care that the gaps to the elevator are flat filled.
 - d) Apply additional glasfibre on the outboard lead piece, see item 3c.
 - e) After curing of the resin mount the roll pins again (drill new 2 mm holes) and grind the roll pins flat.
 - f) Determine the residual moment.
If the residual moment is outside the limit ask the manufacturer for instructions.
