GFA AIRWORTHINESS DIRECTIVE

SUBJECT: Inspection of push rod ends installed in aileron spoiler and elevator drives.

MANDATORY BULLETIN No. BO-78-03-06

SUBJECT: INSPECTION OF PUSH-ROD ENDS

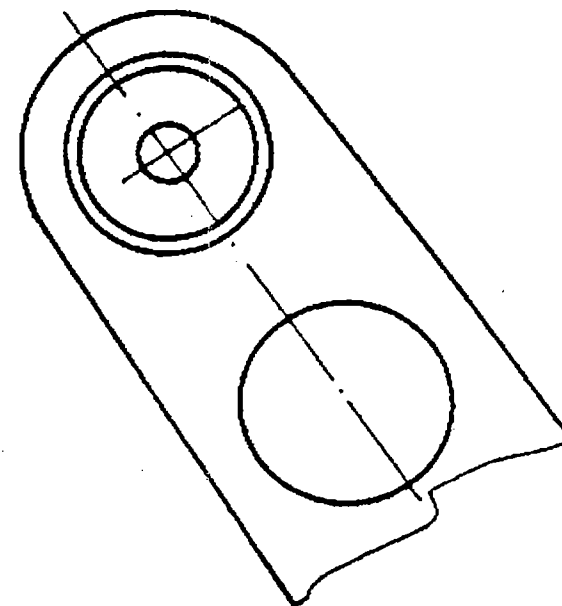
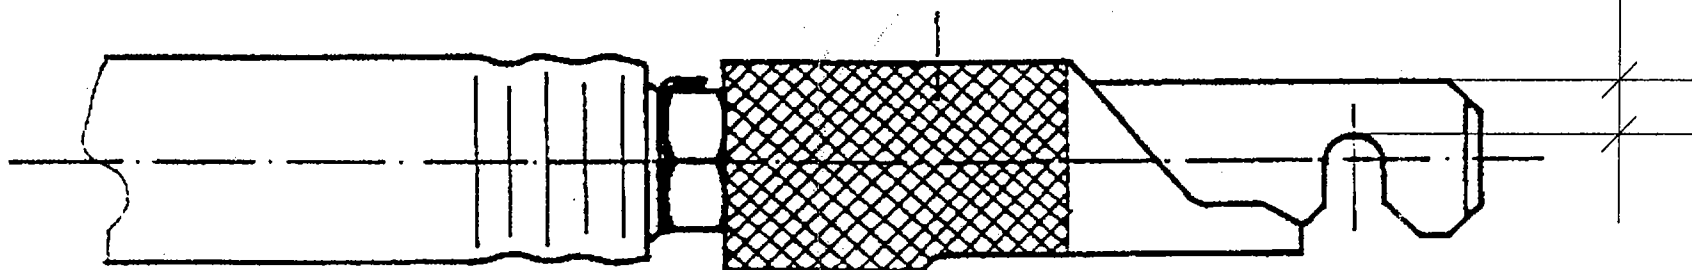
Sketch 1: Push-rod end

In relation to a case of exceeding the minimum dimension of the push-rod end S/N 78.21.215.00.00, it is required to make the measurement of all ends installed in the PW-6U sailplane in accordance with the Sketch No. 1 enclosed to this bulletin. The ends are installed in wings in the aileron control system and in the air brakes (altogether 5 pcs per sailplane).

This bulletin is intended to advise the PW-6U sailplane operators that if the dimension defined on the sketch is found to be less than 4.2 mm, the flights should be discontinued and the sailplane must be parked until a particular push-rod end is replaced with a new one.

$A_{\text{Minimum}} = 4.2 \text{ mm}$

The activities related with measurement of ends shall be performed by the sailplane operator. In case the measured parameter is less than the acceptable one, a new end must be ordered. For this purpose, send the following information to „PZL-Świdnik” S.A. onto the fax No. (+48 81) 468 09 18: sailplane S/N, location of the end installation and measurement result. This shall be the basis for the free-of-charge ordering of a new end at „PZL-Świdnik” S.A. The sailplane manufacturer shall deliver, at his own expense, the new ends S/N 78.21.215.00.00 and the retaining washers preventing the ends against loosening. The ends shall be replaced with new ones by the operator at his own expense.
