GFA AD 615
(ISSUE 1)

GFA AIRWORTHINESS DIRECTIVE

- TYPE AFFECTED:** DG-800B Serial no.s: All up to 8-260 except 8-247 & 8-258.
DG-505MB Serial no.s: All up to 5E220B15 except 5E190B5
- SUBJECT:** Failure of Starter ring gear plate attachment bolts.

Technical Note

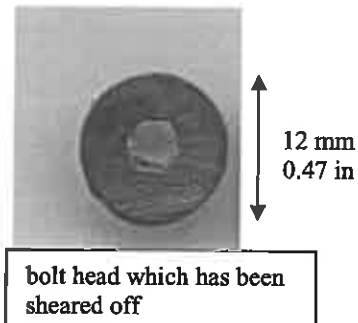
- BACKGROUND:** Instances have occurred where the bolts which attach the ring gear to the lower drive belt pulley adaptor have failed. The sheared off heads have been found in the engine compartment.

- Reason** : In some cases the bolts which connect the starter ring gear to the lower drive belt pulley adaptor failed. The sheared off bolt heads have been found in the engine compartment, see photo.
A method is given herewith to repair the existing part for a durable connection.

- ACTION REQUIRED:** **ACTION 1.** Prior to and after each flight, inspect the engine compartment for sheared off bolt heads. Should any be found, or if damage is suspected, the engine is not to be used until modifications are carried out according to ACTION 2.
ACTION 2. Modify the connection in accordance with the Technical Note and Working instruction. The work must be certified & entered in the aircraft's logbook by the holder of a G1109 Airworthiness Authority with a Section 2 Certificate endorsed for engine accessory replacement, or higher maintenance authority.

- Instructions** : 1. Search for bolt heads prior to and after each flight. If a bolt head is found, the engine should not be used any more to prevent from further damage.
2. a) Modify the connection according to working instruction No. 1 for this TN.
b) If the aircraft logs prove that the modification has already been executed (according to DG service info 48/02) the repair has to be inspected and entered in the aircraft logs by a licensed inspector
