**GFA AD-627**  
(ISSUE 1)

**GFA AIRWORTHINESS DIRECTIVE**

**SUBJECT:** Failure of flap drive mechanism in fuselage.

**SUBJECT:** Flap drive mechanism in the fuselage

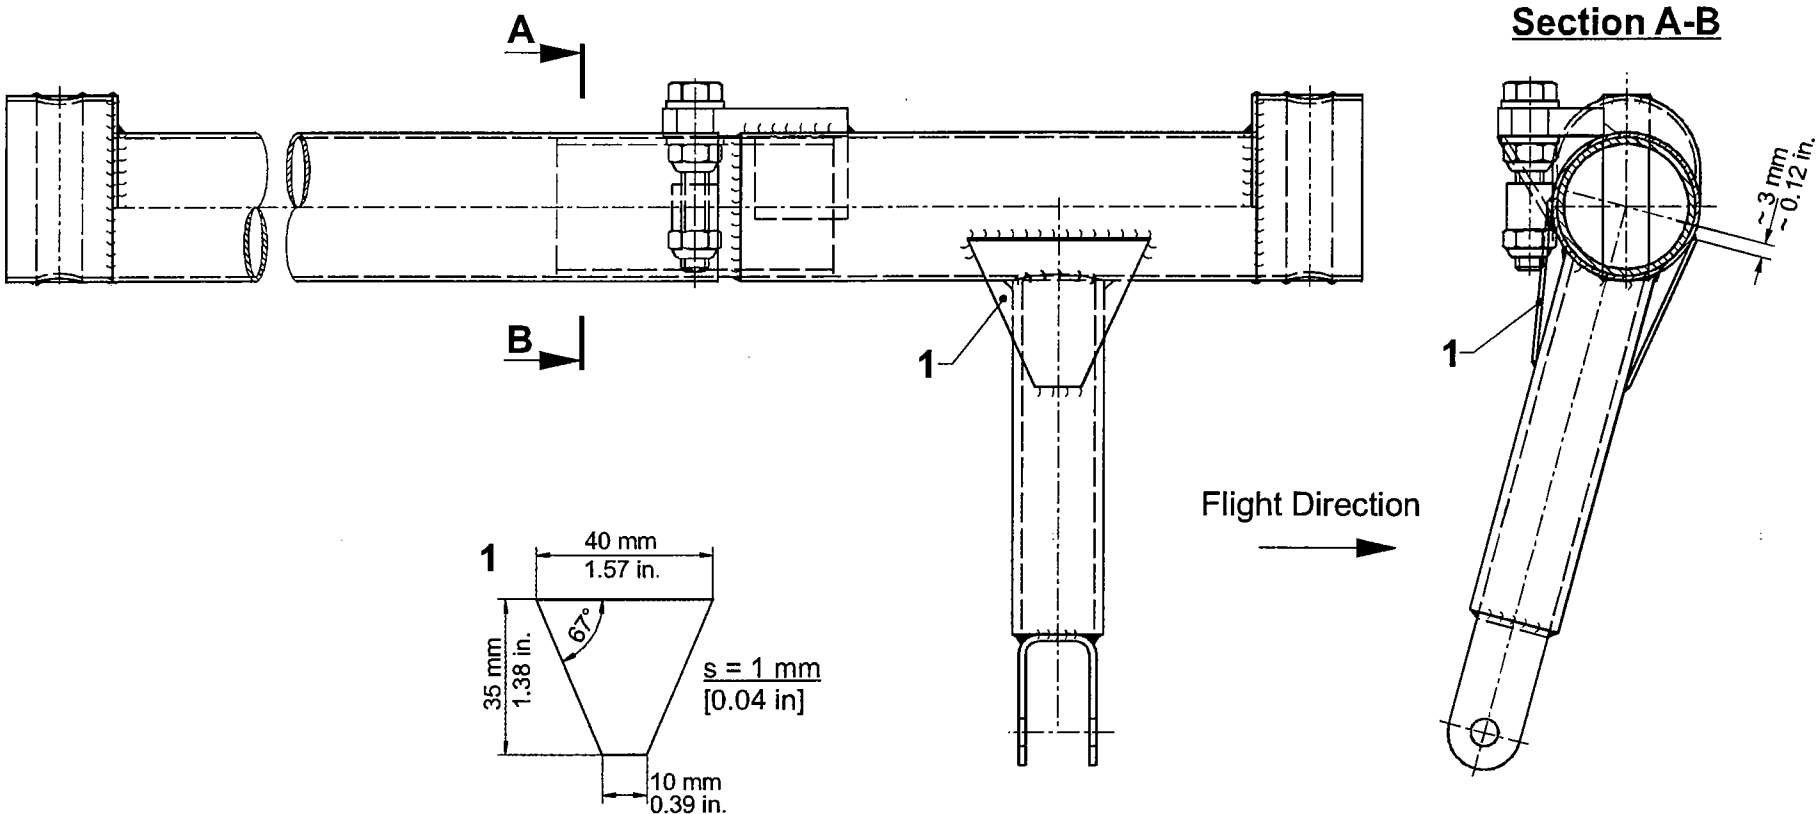
## TN 286-35

**REASON:** During the daily check after assembling a Mini Nimbus C a failure in the flap actuating circuit was found.  
 An investigation showed that the lever at the torsional drive in the fuselage failed at the weld.  
 Because of the equal design of the torsional drive the sailplane Nimbus-2C is affected too.

**ACTIONS:** The reinforcement of the flap drive is accomplished in accordance with the following drawing and with the appendix to the Technical Note.

- b) Weld reinforcement plates according to drawing No. 10.065/3, see page 02 of this appendix.
