GFA AIRWORTHINESS DIRECTIVE

SUBJECT: Inspection of engine Magnetic Plug.

CHECKING OF MAGNETIC PLUG ON ROTAX® ENGINE TYPE 912/914 (SERIES)

ASB-912-051
ASB-914-034

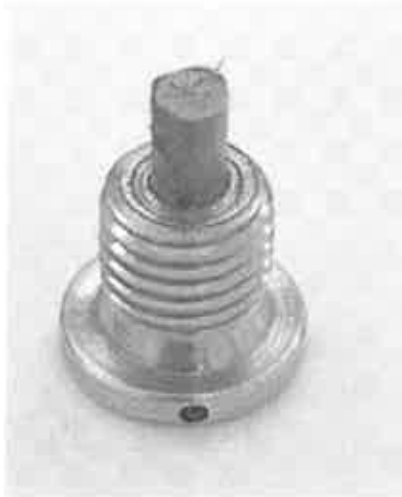
fig 1

acceptable

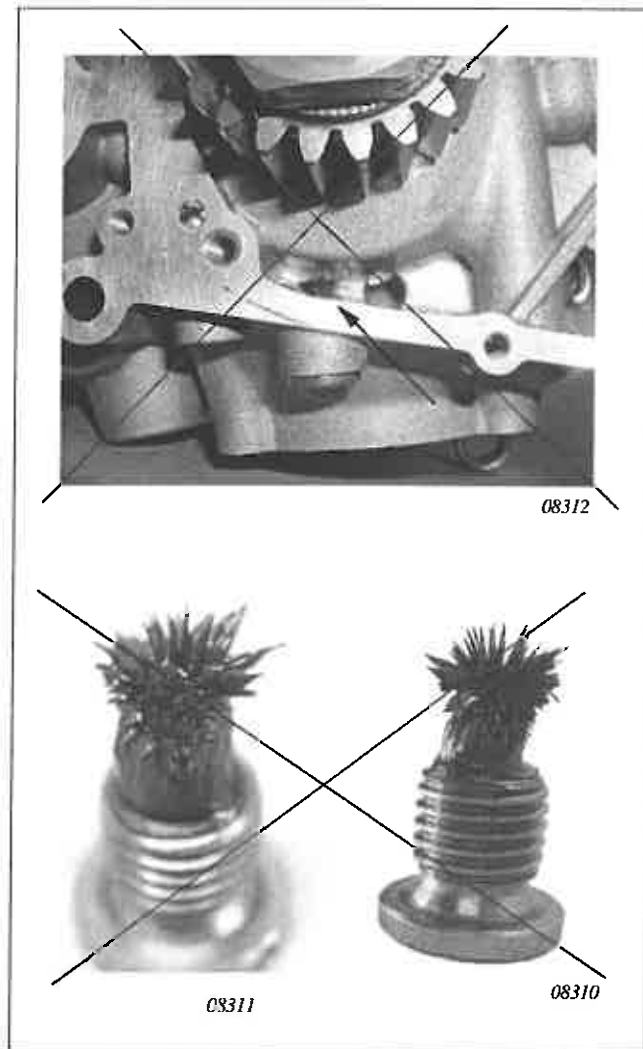
fig 2

■ **CAUTION:** If a greater quantity of metal particles (more than 3 mm (1/8")) is detected, consultation of an authorized distributor regarding further action is necessary. The engine must not be taken into operation until the cause has been identified and eliminated.

not acceptable
